Extrication Zone, Technical Rescue

Firefighters Respond to Paducah (KY) Truck into Building

Photos and incident report from Jeremy Rifflard

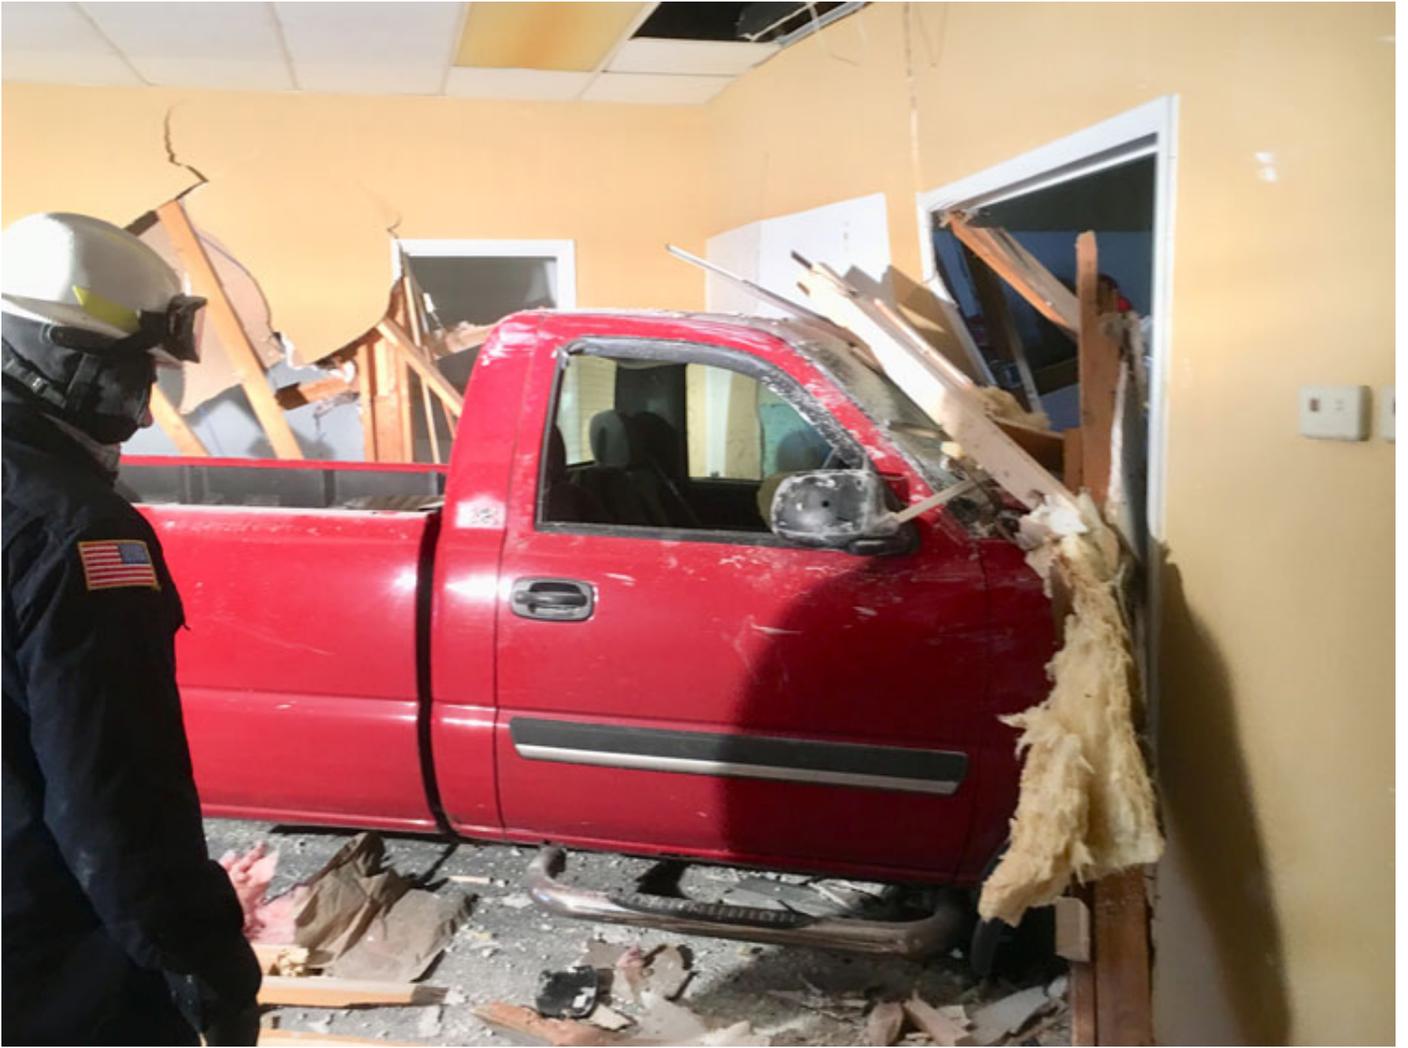
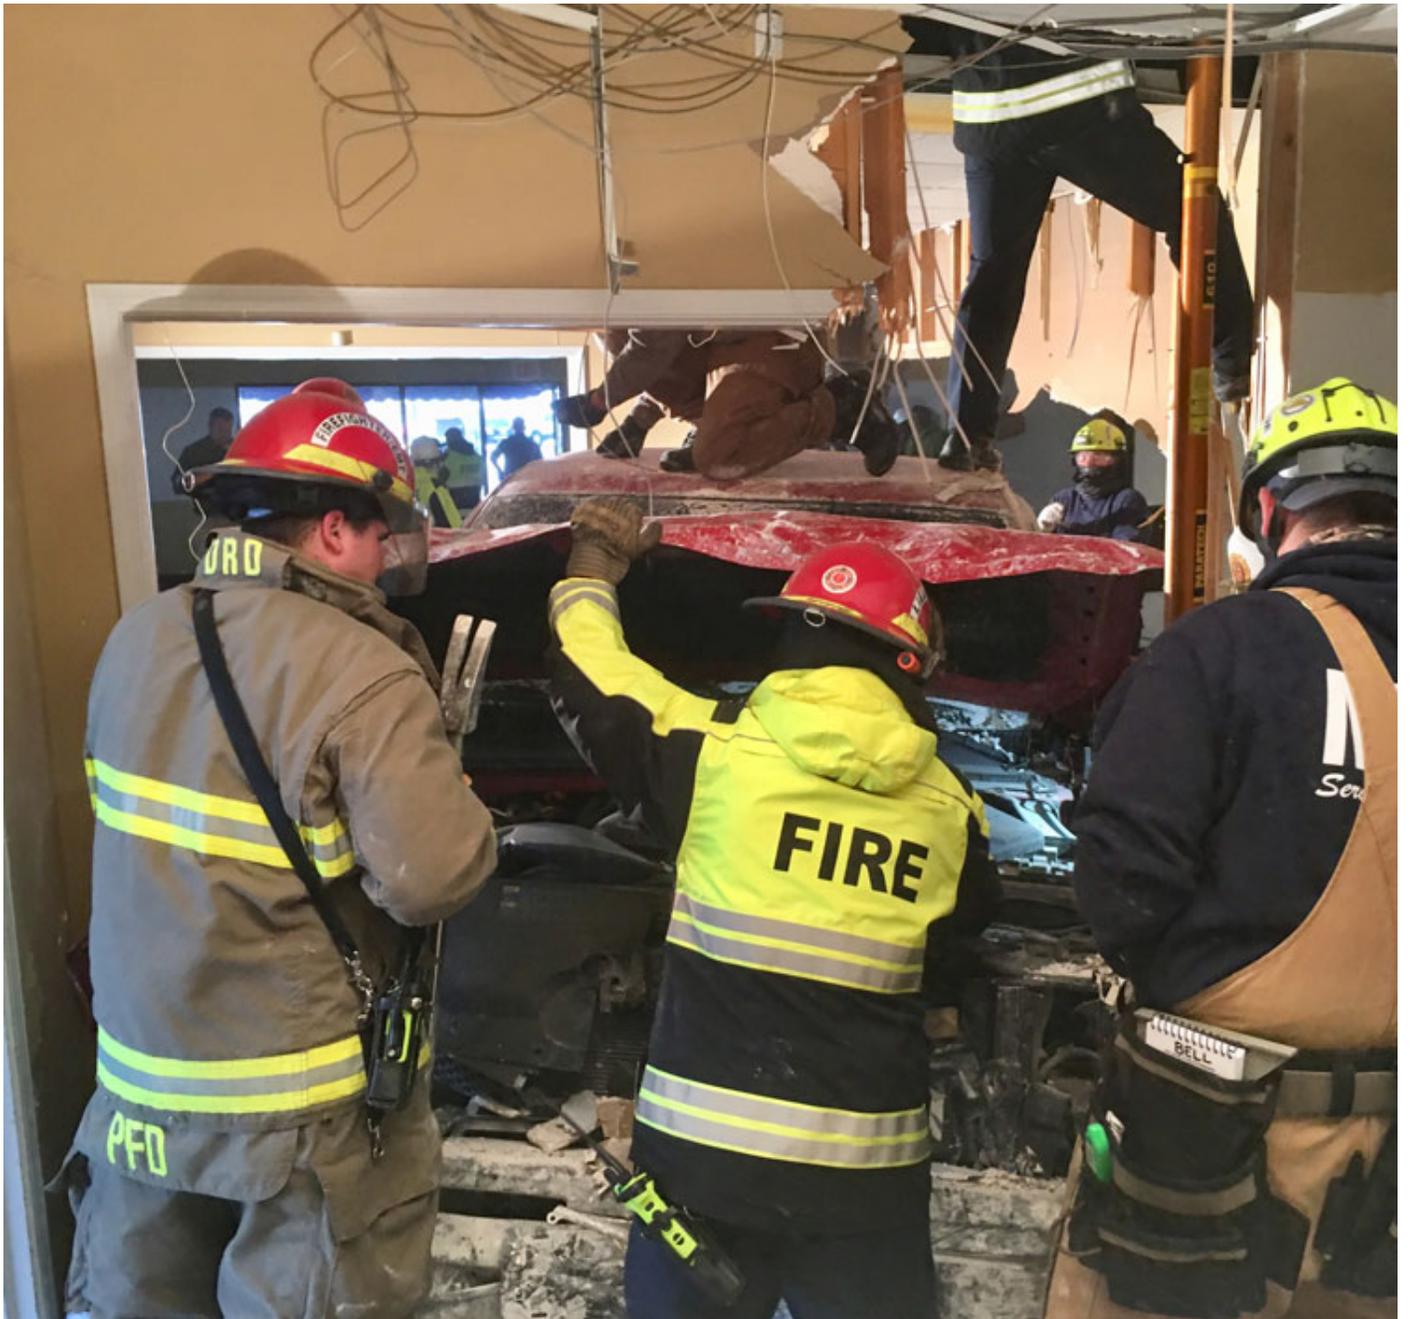
(1-2) A pickup truck traveled 30 feet into the vacant music store coming to rest under a load-bearing wall that it damaged.

The building inspector was concerned about the damage to the third load-bearing wall where the truck came to rest. The responders developed a shoring plan to immediately install a pneumatic shore extending from the concrete floor, clearing away a suspended nine-foot drop ceiling, to the header, which was just less than 13 feet in height. The plan called for additional shores to be installed after the pickup truck was moved from under the load-bearing header. This is where the technical rescue team would construct and install a two-post vertical shore and attach it to the wood girder. Because of the tall height of the shore, it would require two midpoint braces.

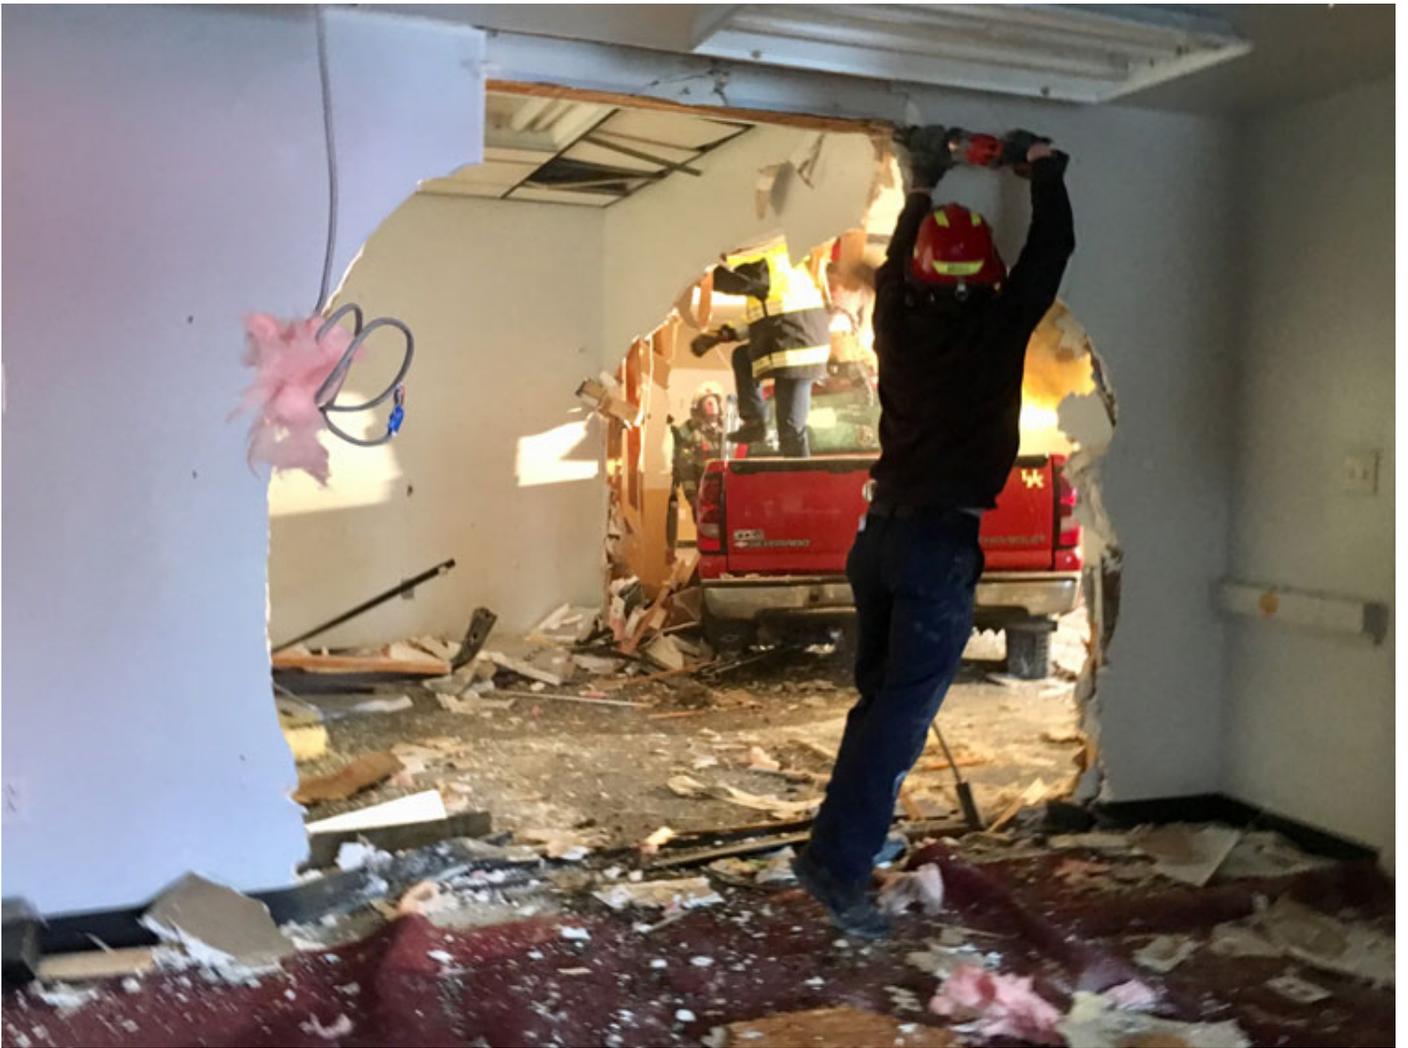
(3) Rescuers cut damaged wall sections to expose the structural members that will be shored.

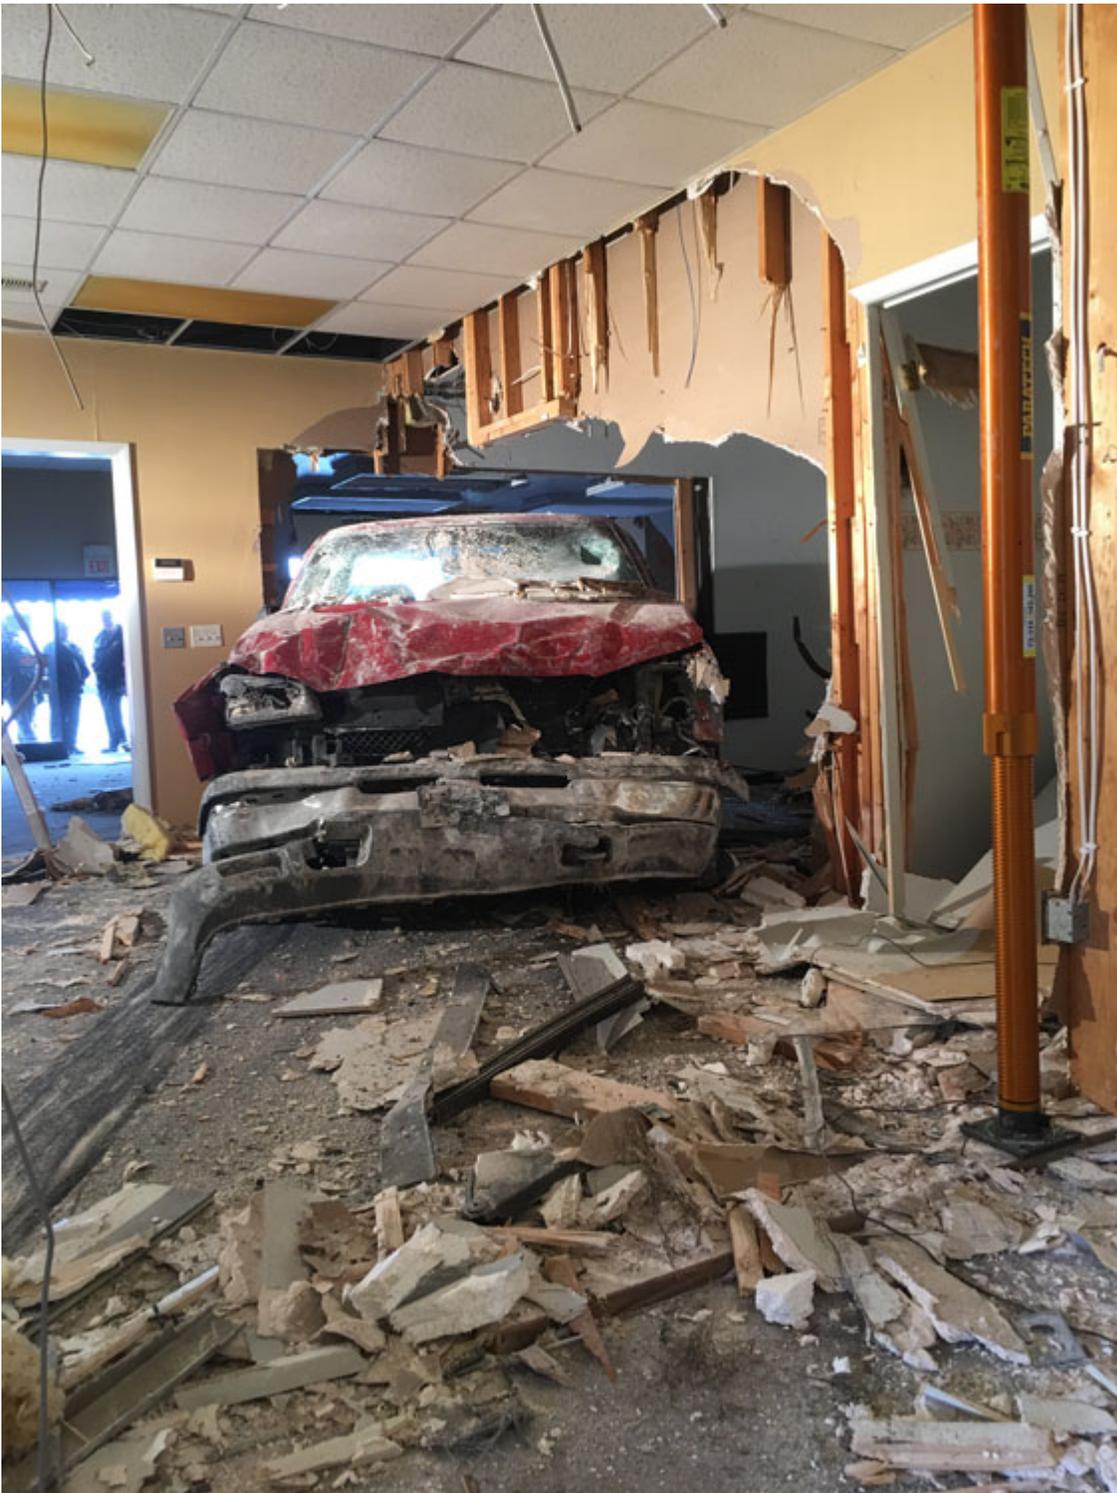
(4) Rescuers widen a path to pull the truck out of the building without striking the remaining walls.

The interior wall and the second load bearing wall in the middle of the structure were not significantly damaged and did not require additional shoring. Those walls did need to be partially removed to facilitate pulling the truck back through those areas without striking the undamaged part of the walls.

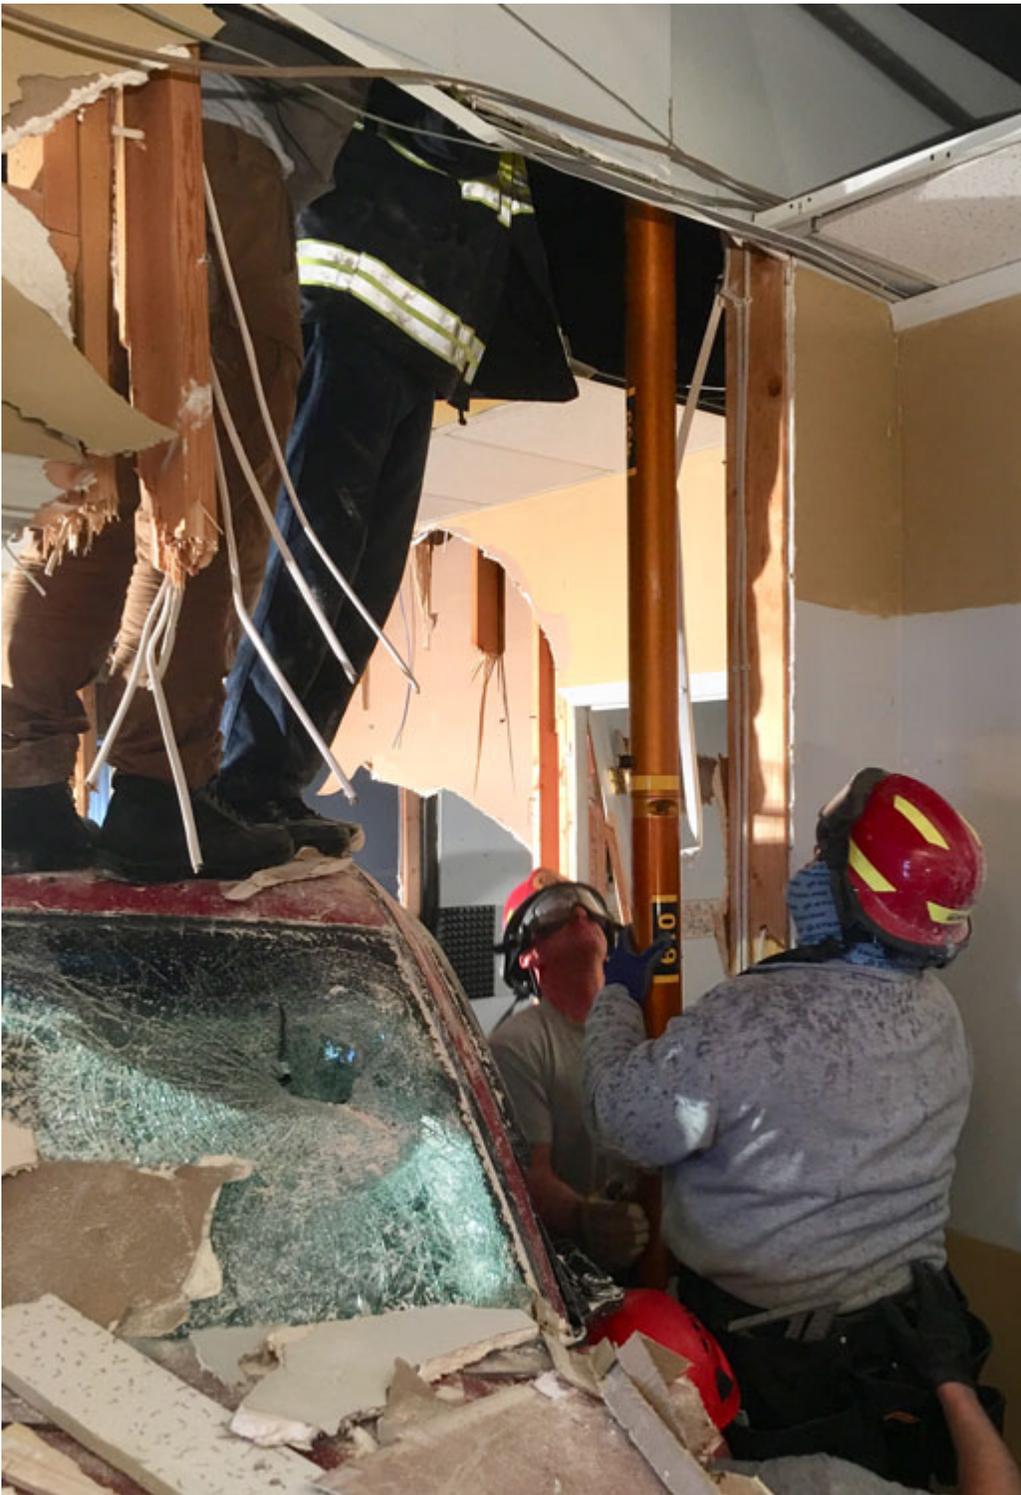
(5) Firefighters install a pneumatic shore next to the pickup truck.

The shoring squad constructed a pneumatic shore comprised of a six- to 10-foot shore with a 4-foot extension. Within minutes, this shore was installed vertically. The shore was installed close to the truck and nailed to the building header and sole plate. The shoring team took measurements of the opening created from the vehicle and began constructing the two-post vertical shore.

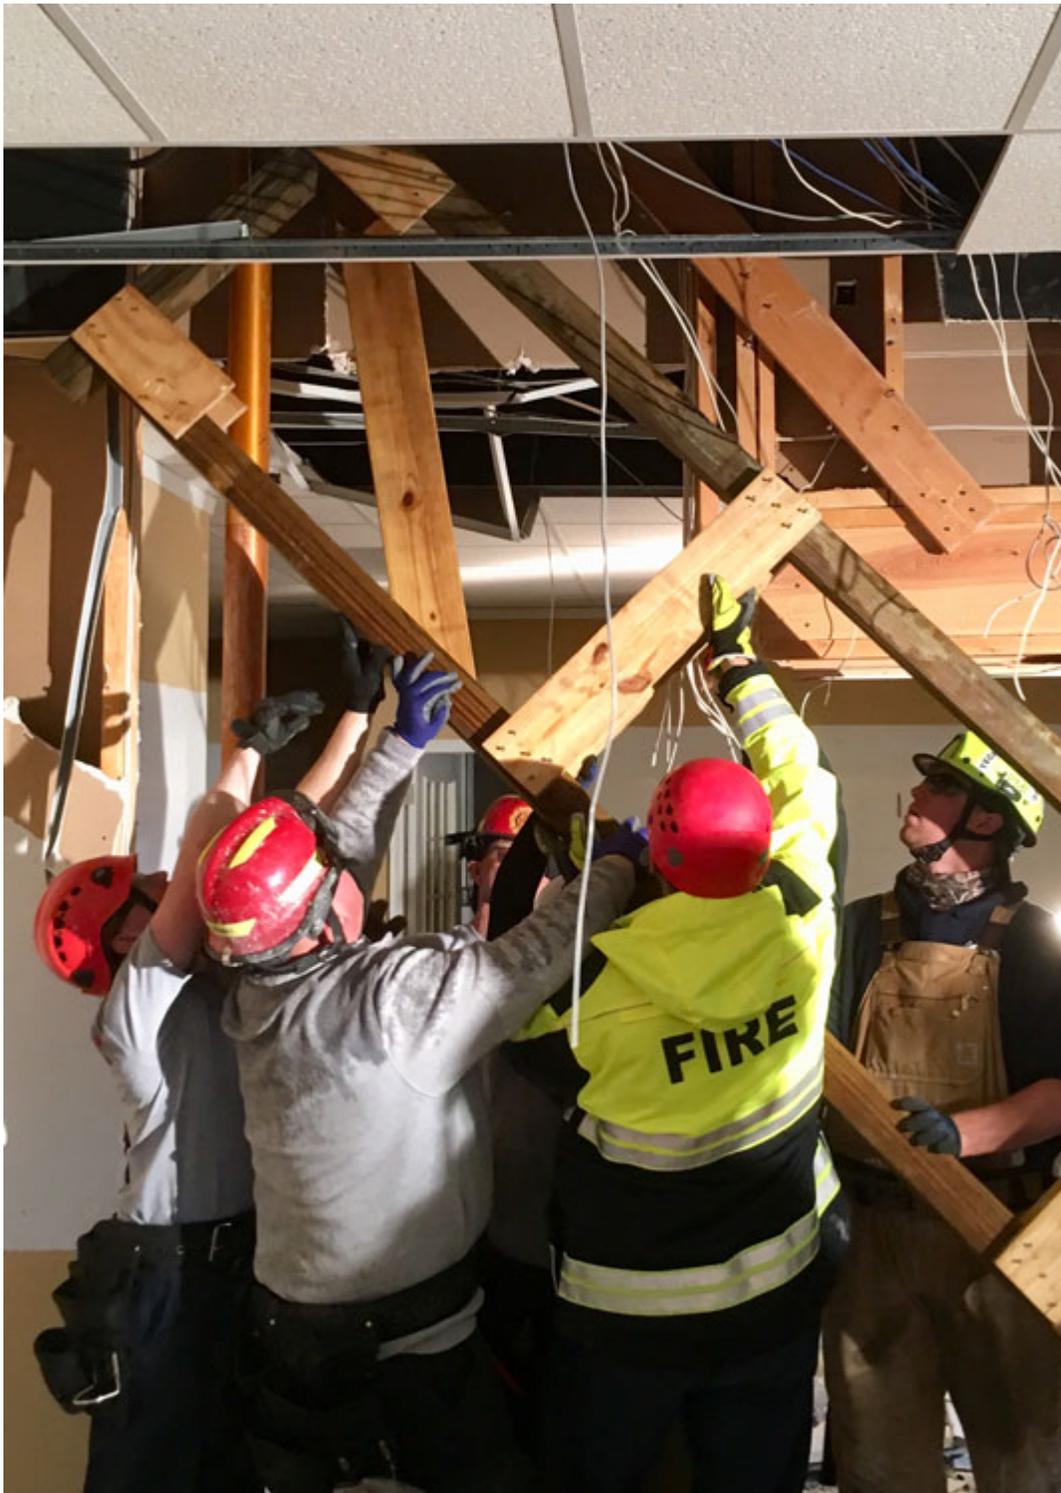
(6) *The Paducah Technical Rescue Team installs a two-post vertical shore.*

The truck was pulled back through the load bearing wall with the use of the tow truck cable and a winch. The wooden two post vertical shore was installed next to the pneumatic shore. After the two-post shore was pressurized with 2×4 wood wedges under each post, the pneumatic shore was removed and returned to the TRT trailer.

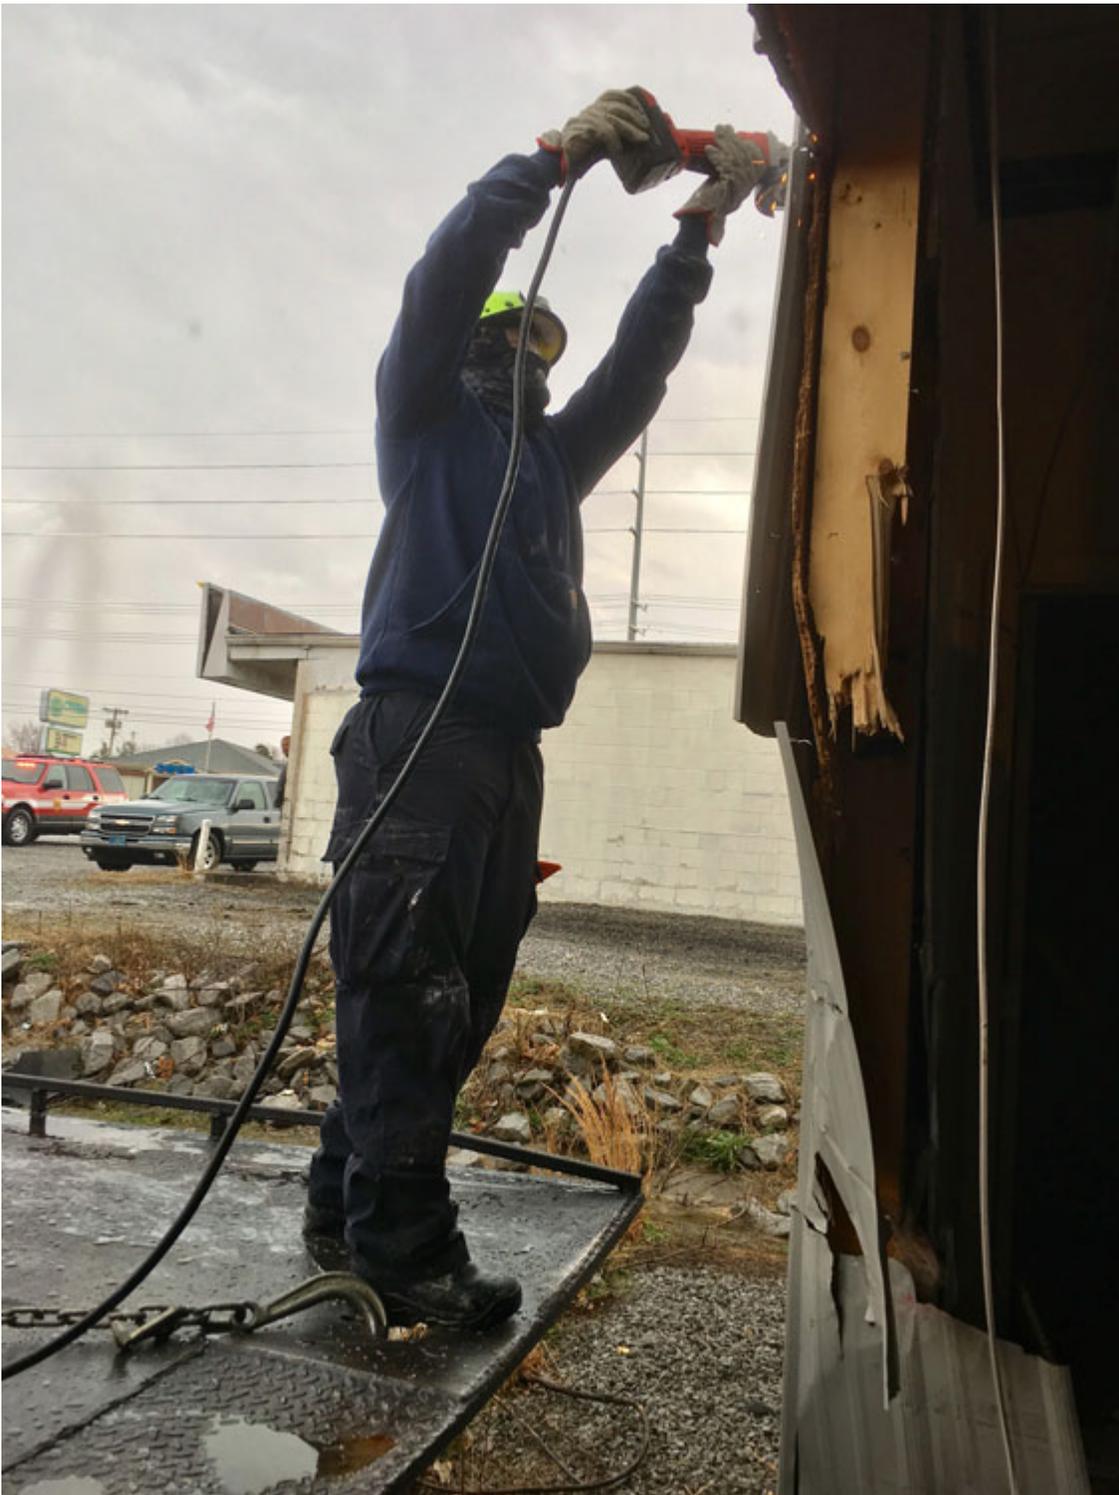
(7) Firefighters cut the metal exterior wall to create access for the tow truck bed.

The exterior load-bearing wall was metal paneling over 2×6 wood studs with insulation and interior drywall. This opening was enlarged and squared up to the unbroken wooden studs to create an opening large enough for the vehicle to be removed by a tow truck. The bed of the tow truck was extended onto the structure through this opening to add an anchor for a diagonal pull, which was needed to avoid striking the interior walls.

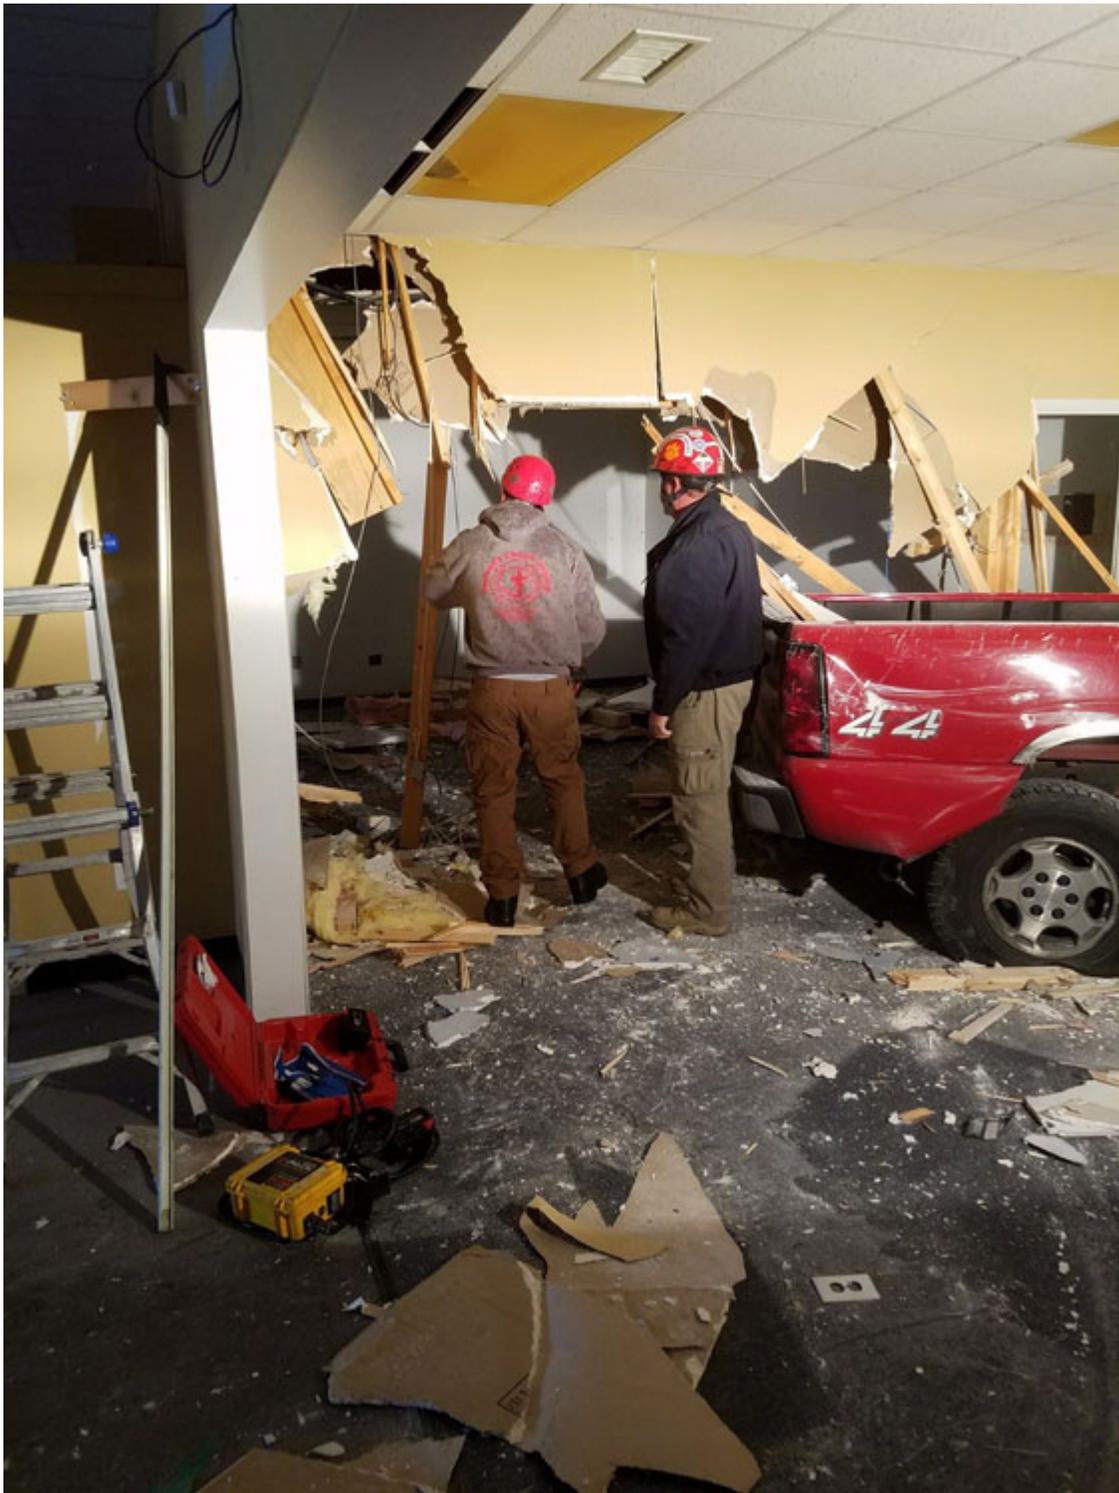
(8) Technical rescue team firefighters clear a path through the structure.

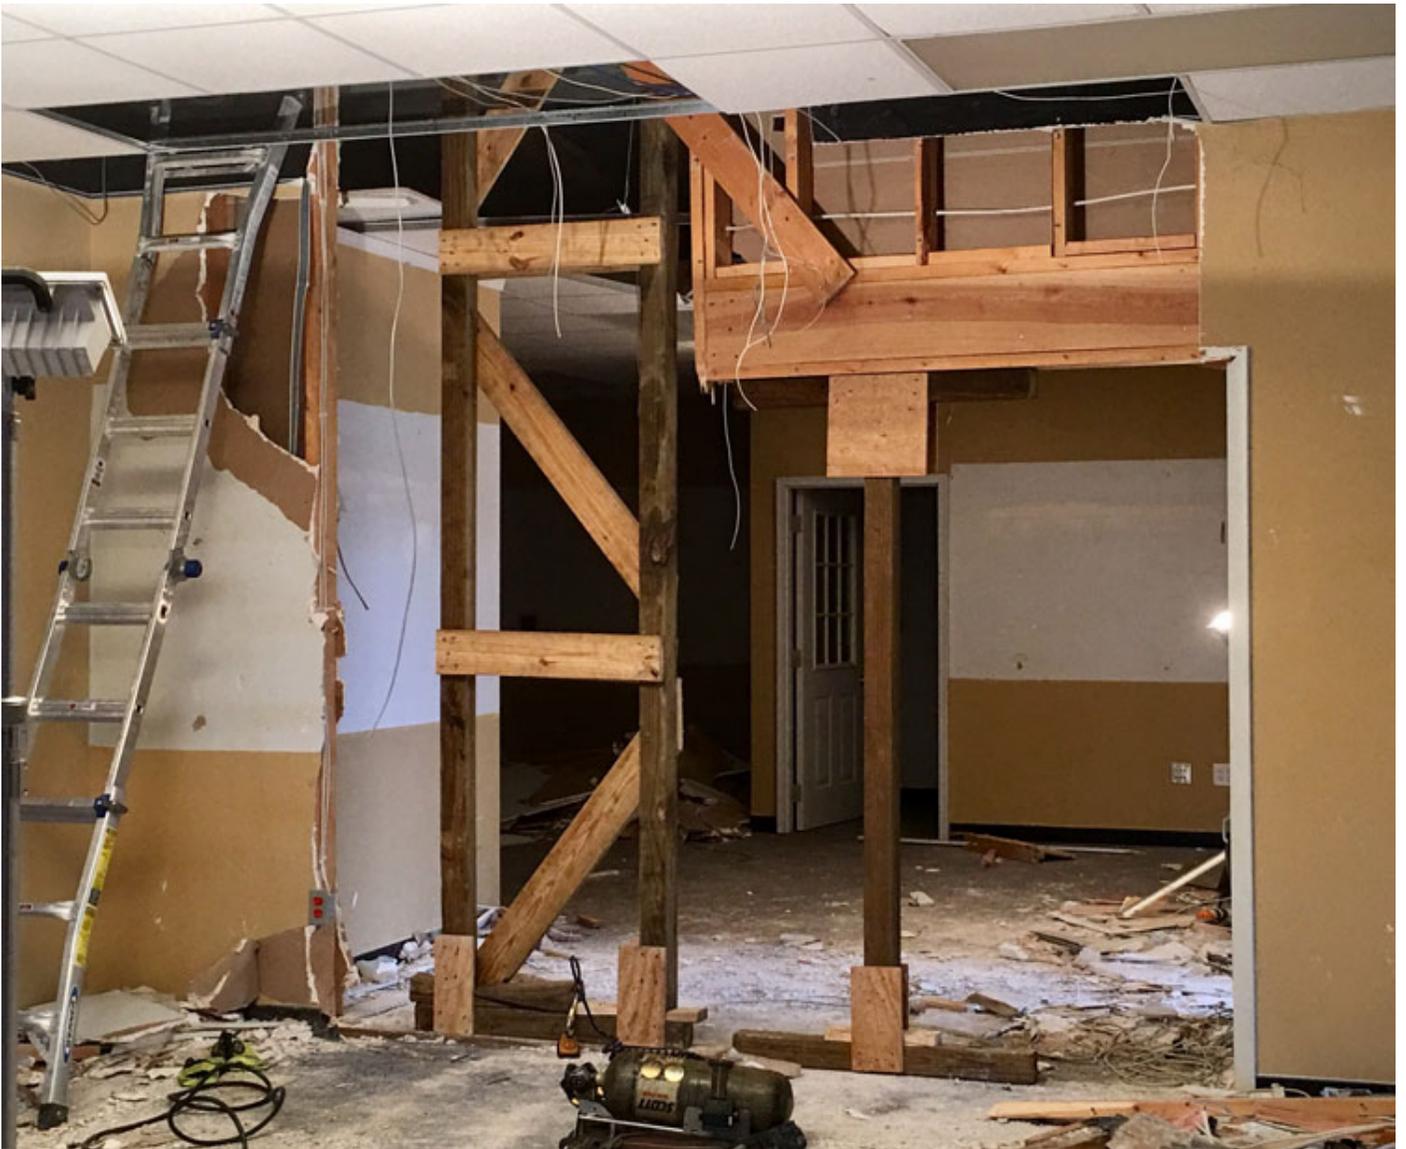
Another section of the wall that went from the six-foot, eight-inch doorway height to the 13-foot underside of the roof beams was damaged from the initial impact. This wall is where the spot T shore was installed. The wood shore header and sole plates were toe-nailed into the existing wooden header and sole plate of the building, which is anchored into the concrete floor. Toe-nailing the shore will keep it in place, just in case it was accidentally bumped into during follow up inspection of the structure.

(9) The two-post vertical shore and the T spot shore installed to support the weakened wood girder that was supporting two roofing systems.

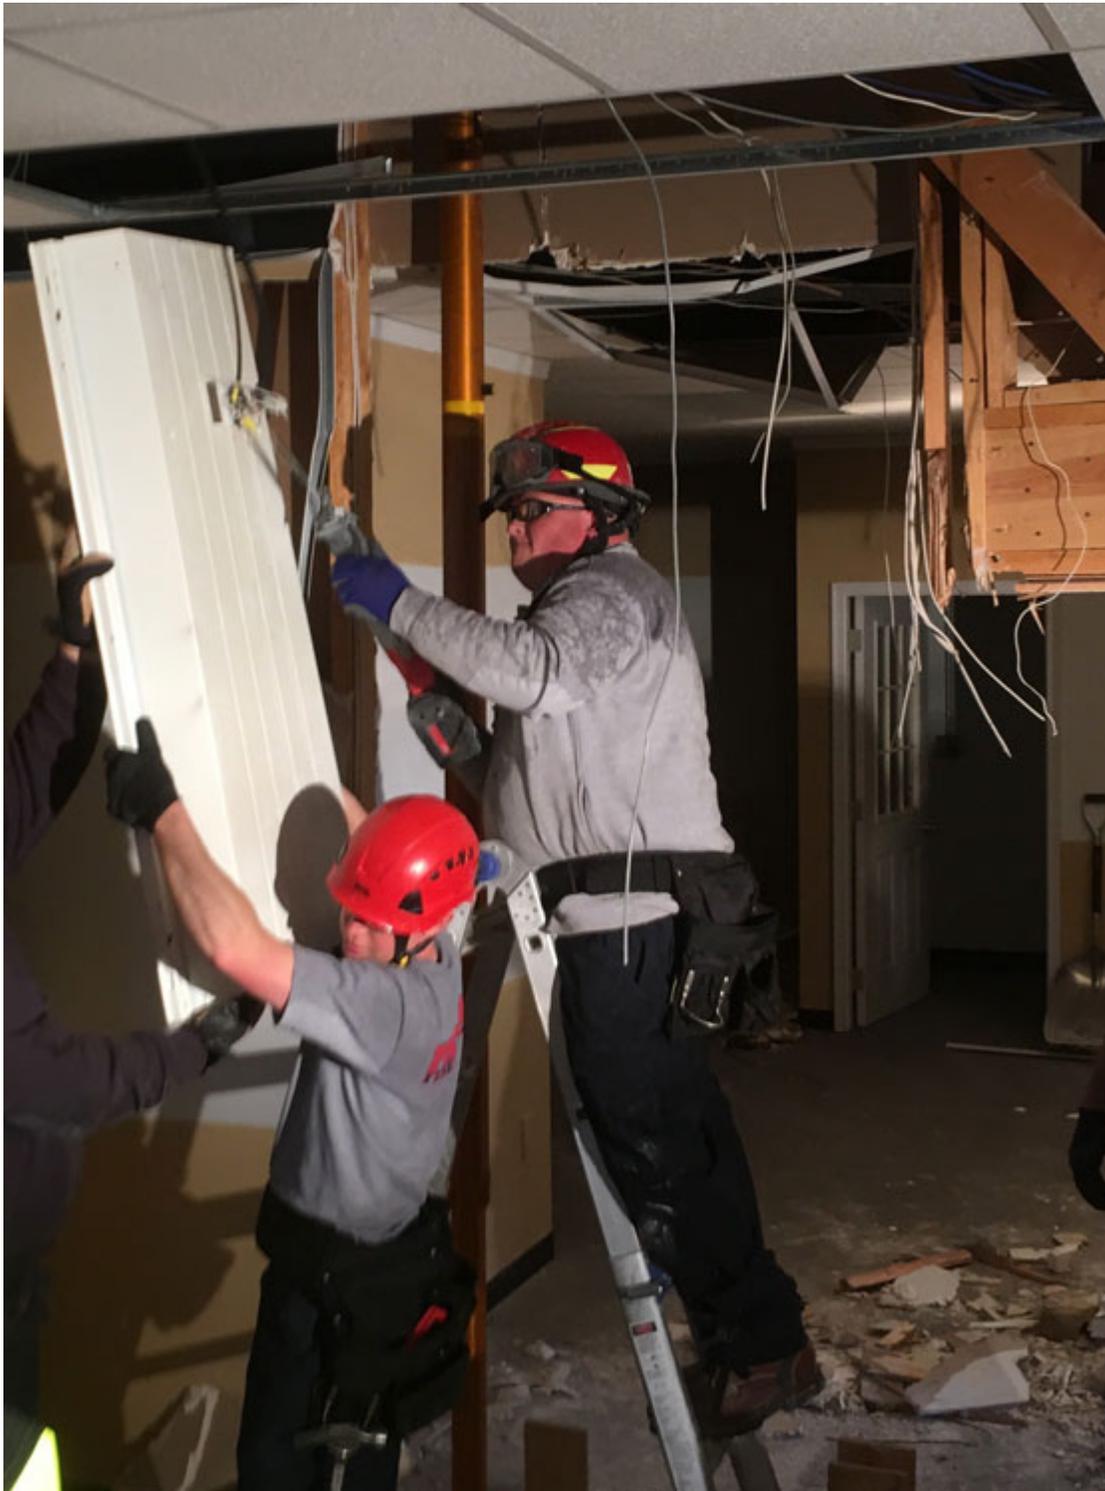
The TRT needed to see the underside of the load-bearing beam. The ceiling and wall needed to be exposed to create access and view the location of the vertical shores. The drop ceiling system at the nine-foot height contained several heavy four-foot-long lights. As the drop ceiling was removed, some lights dropped down and swung sideways

on the electrical conduit. These lights had the potential to strike a responder. All lights and cable were cut away to prevent injury or entanglement.

(10) Firefighters remove suspended lighting.

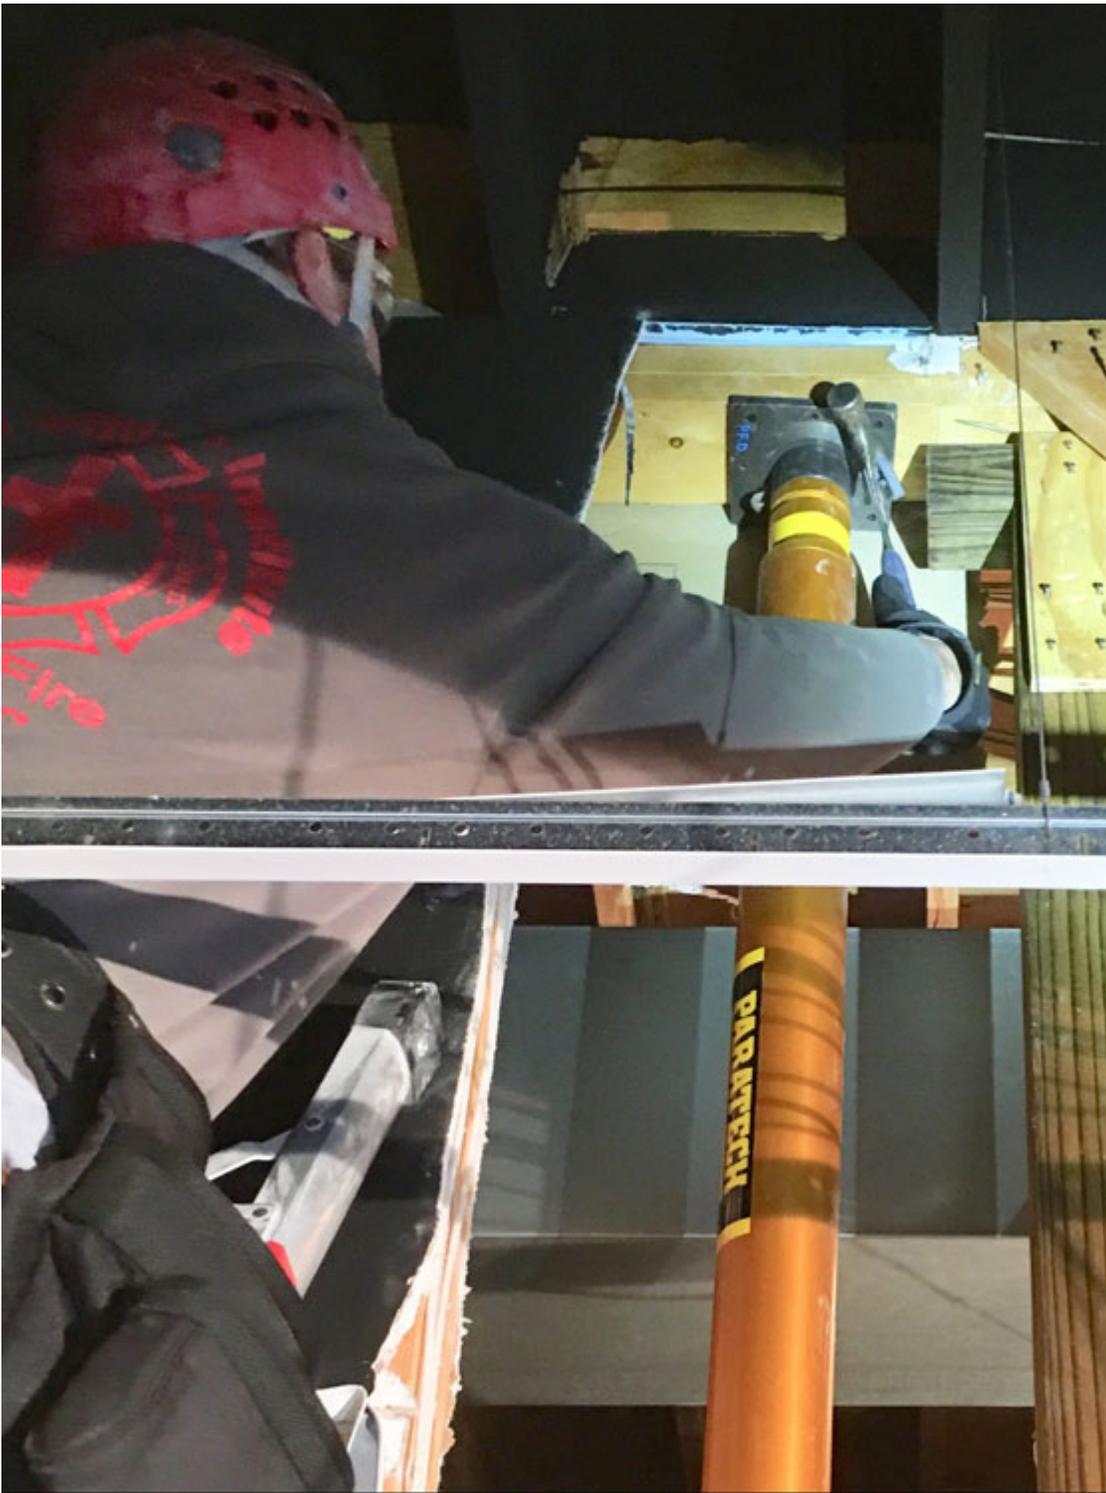
While working in the area secured with the pneumatic shore, TRT firefighters began clearing out broken wooded studs by cutting near the header and prying the small remaining part of the boards. This action left the nails in the header protruding downward. The end of the nails prevented an accurate fit of the wood two-post vertical shore. Firefighters corrected this by using a recip saw to cut off the nails.

(11) *Technical rescue firefighters clear nails from the girder.*
