## **Reducing Parking Lot Injuries, Storefront Crashes, and Tort Claims: Safety Bollards, ADA Parking Signposts, and “Wheel Stops”**

*(A Joint Position Paper of the Storefront Safety Council and Richard Avelar & Associates)*

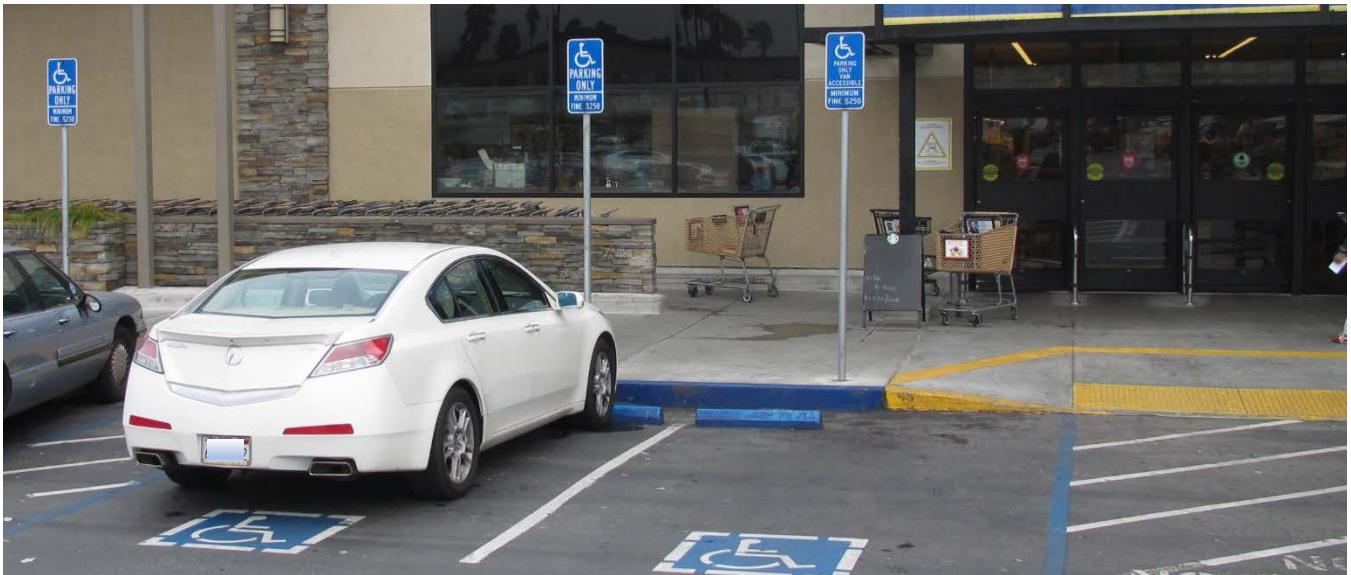
At these accessible parking spaces in San Francisco, CA, the only minor purpose for these concrete wheel stops (which constitute a major pedestrian tripping hazard) is to help deter vehicle interactions with the metal ADA signposts.

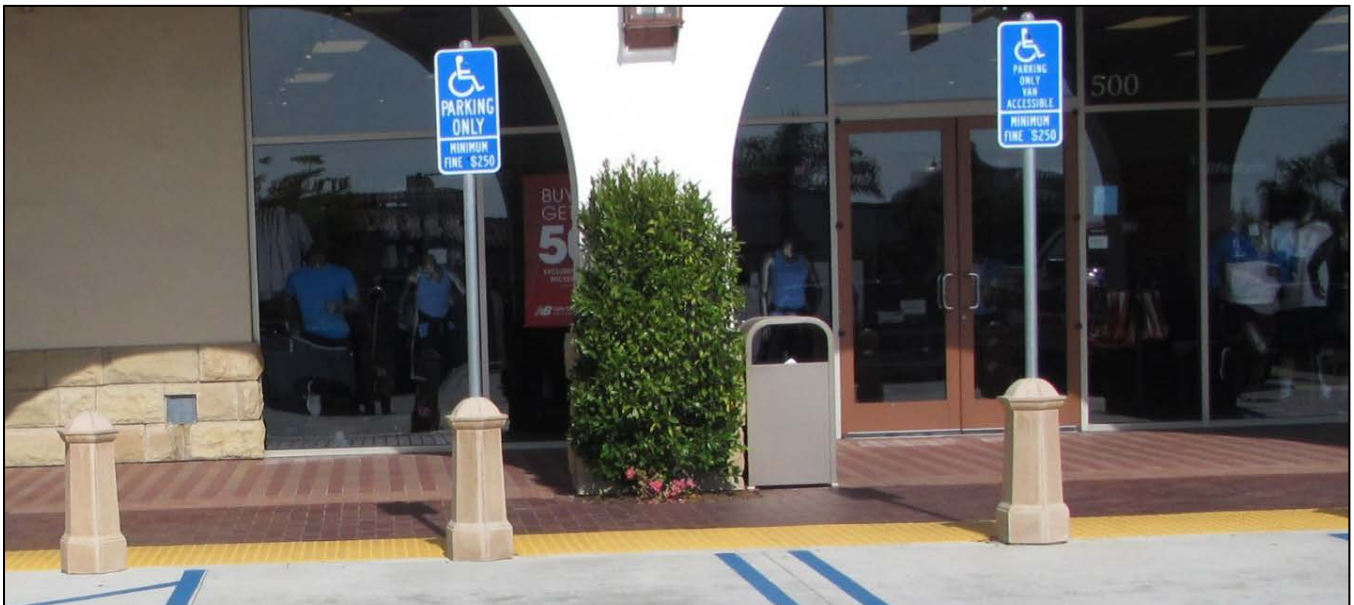
Vehicle-safety bollards protect the required ADA signposts at these well-designed parking spaces in San Clemente, CA.

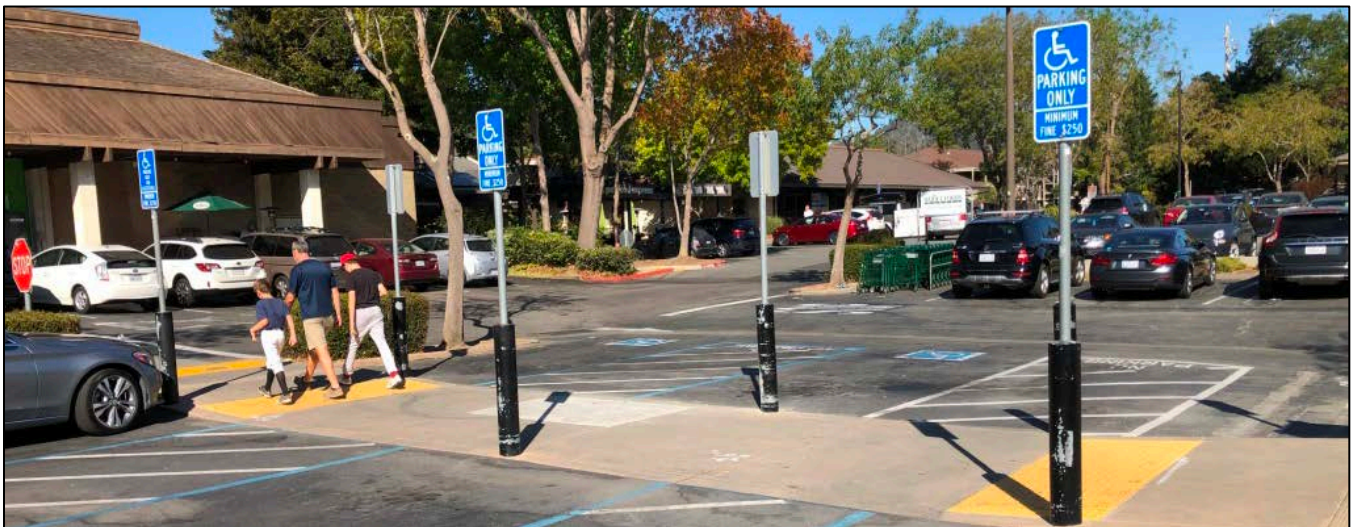
Safety bollards similarly protect the required signposts at these well-designed parking spaces in Mill Valley, CA.

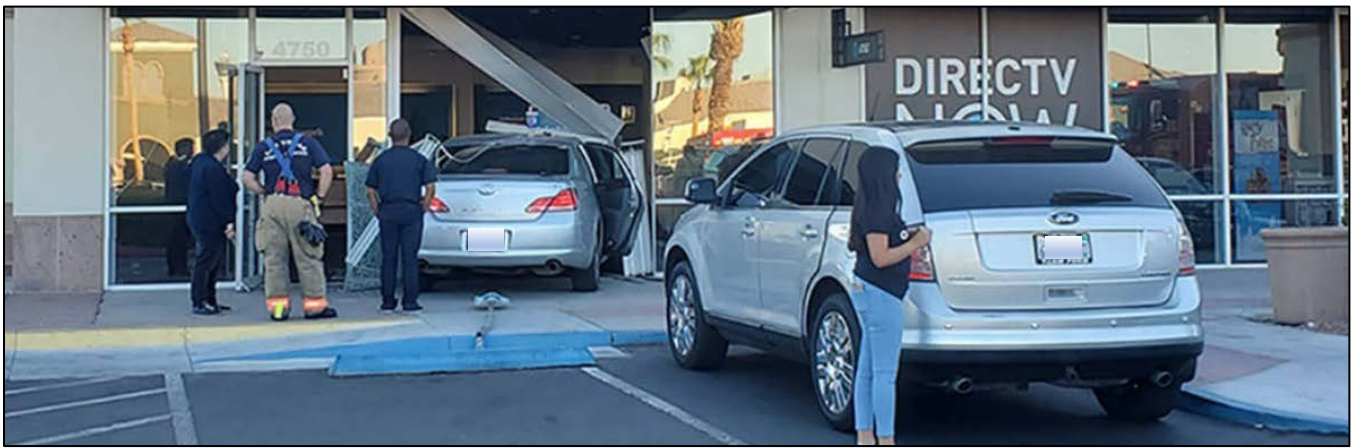
**In Las Vegas, this vehicle was not stopped by either the 'wheel stop' or the now-flattened ADA signpost.**

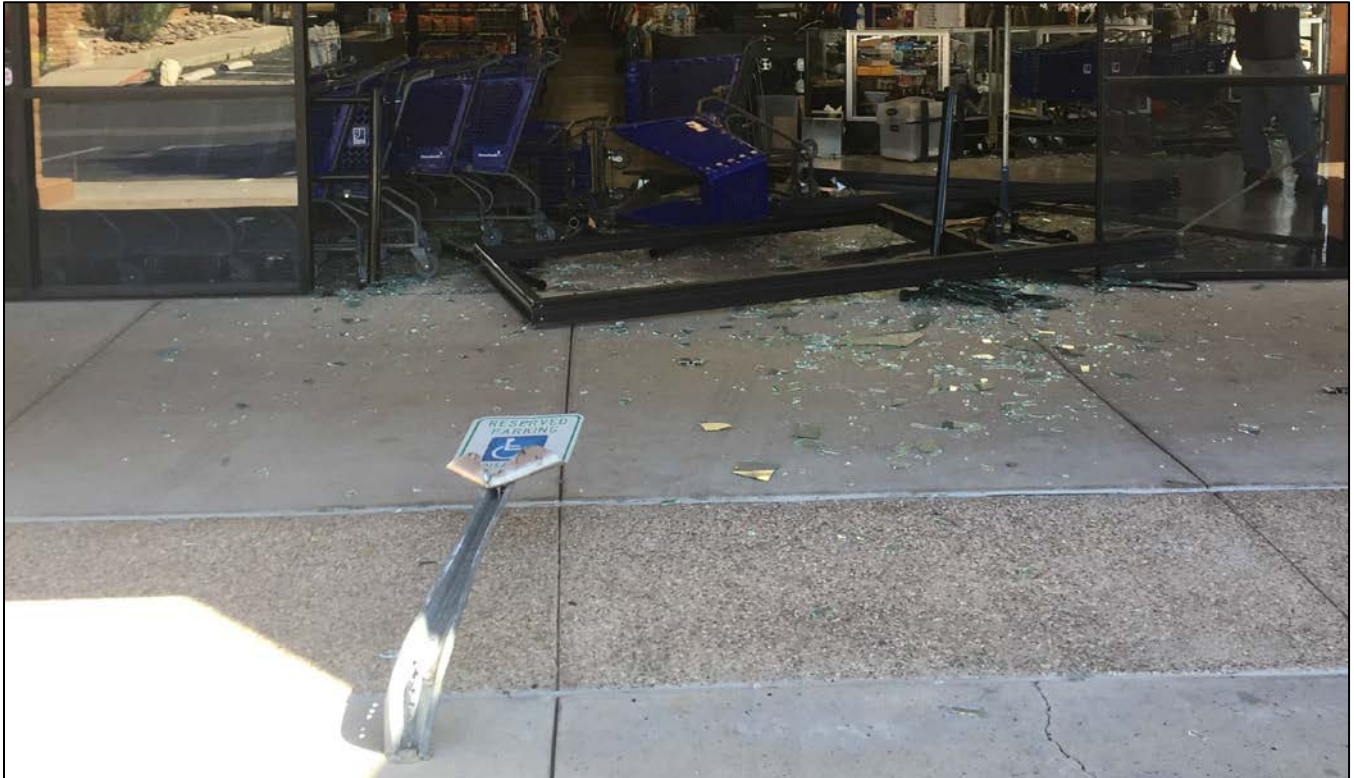
**Typical metal signposts supporting ADA signage simply cannot protect buildings or pedestrians.**

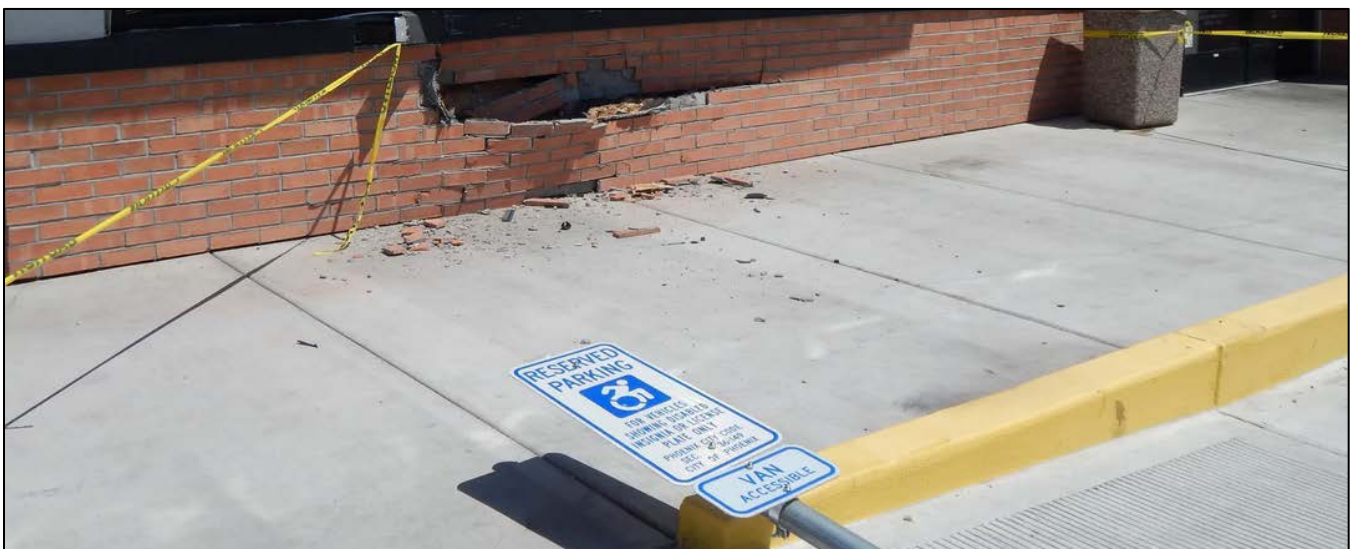
**This typical ADA signpost could not protect this storefront in Phoenix, AZ.**

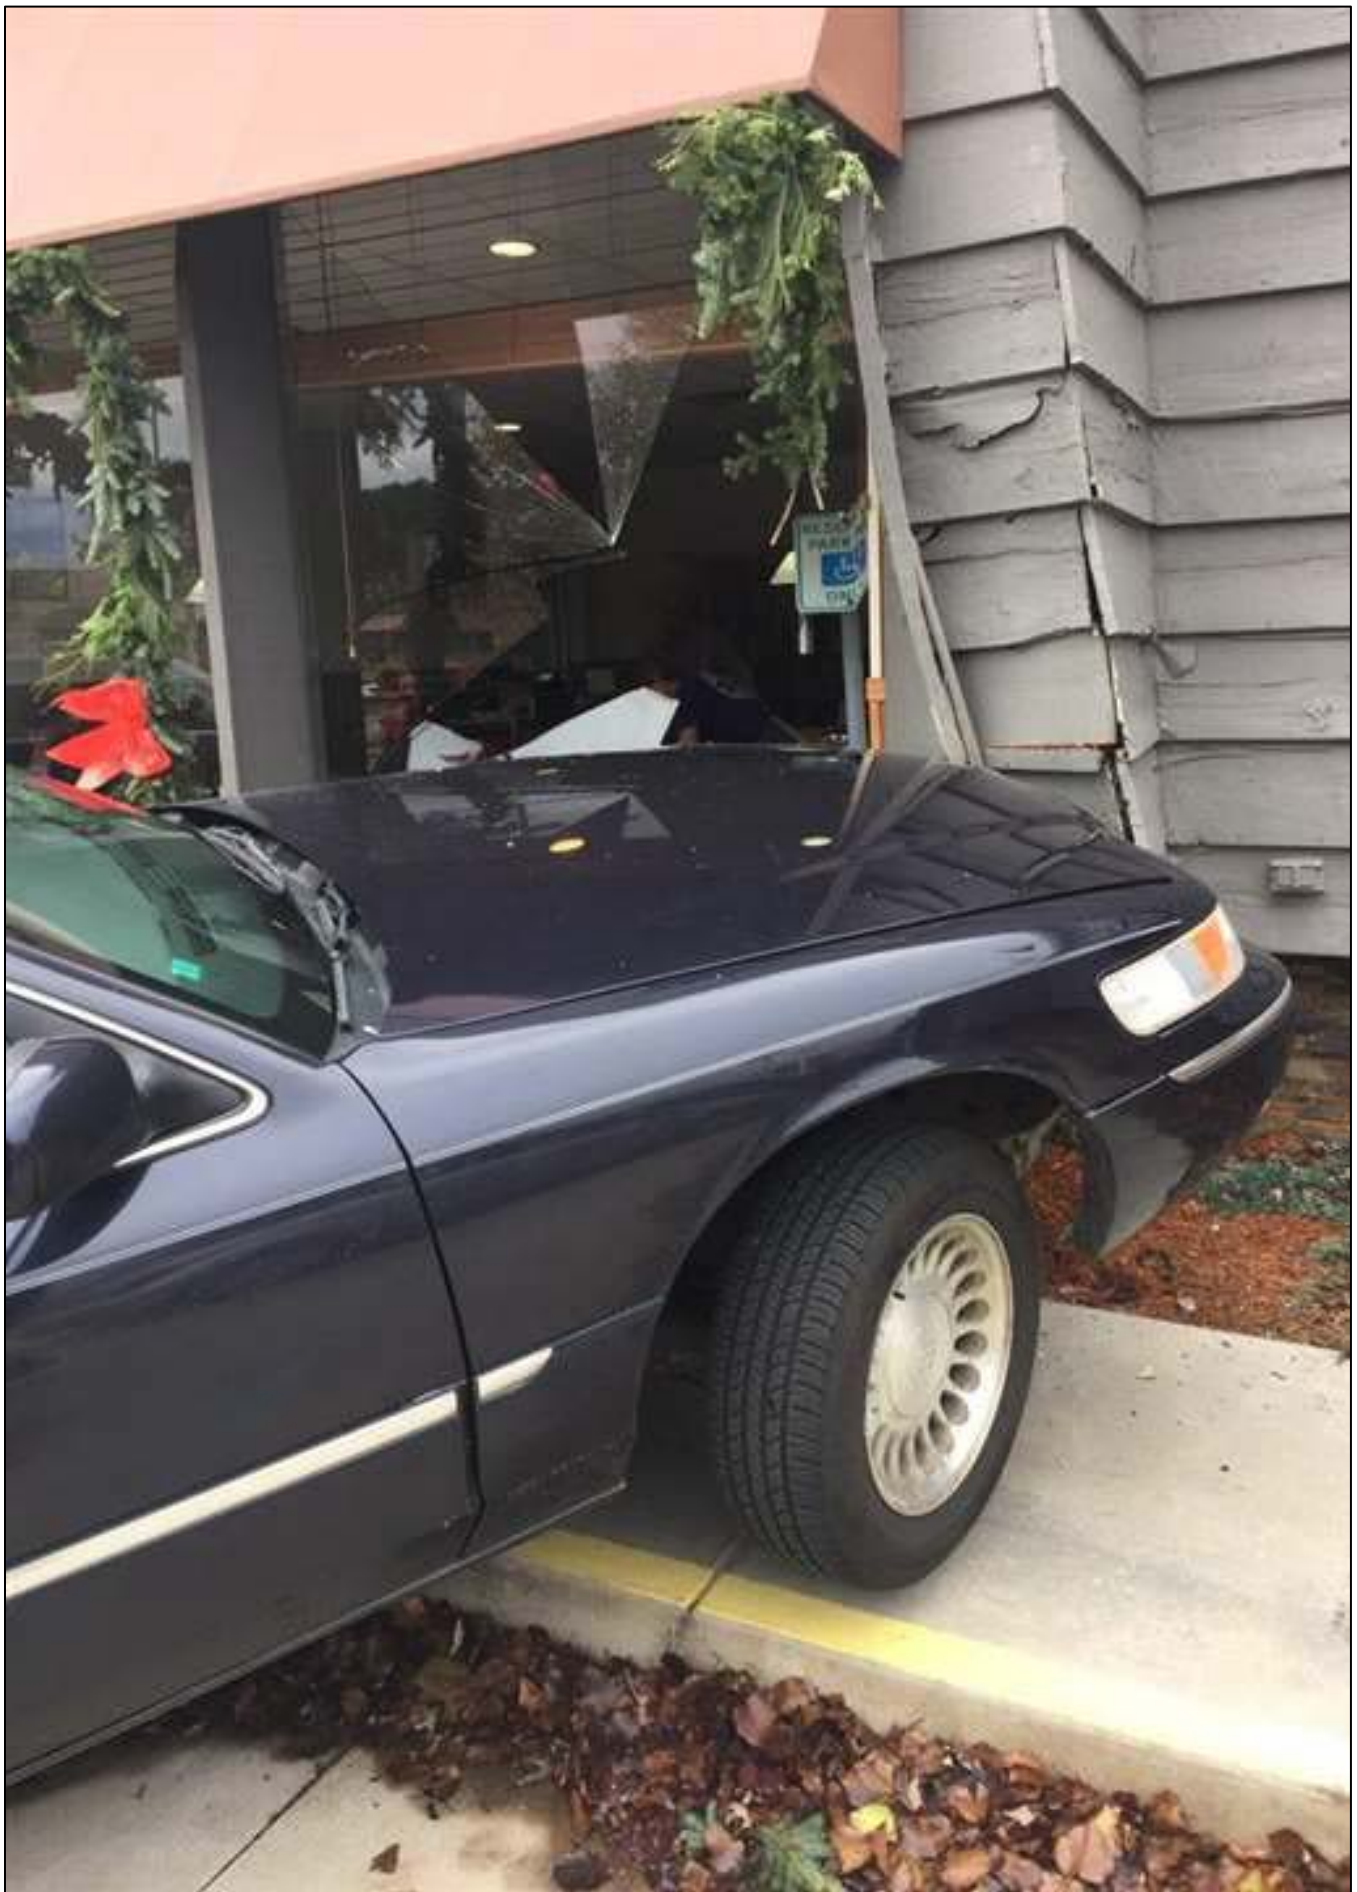
**At this smashed window and wall in Grand Haven, MI, note the crumpled metal signpost with ADA signage.**

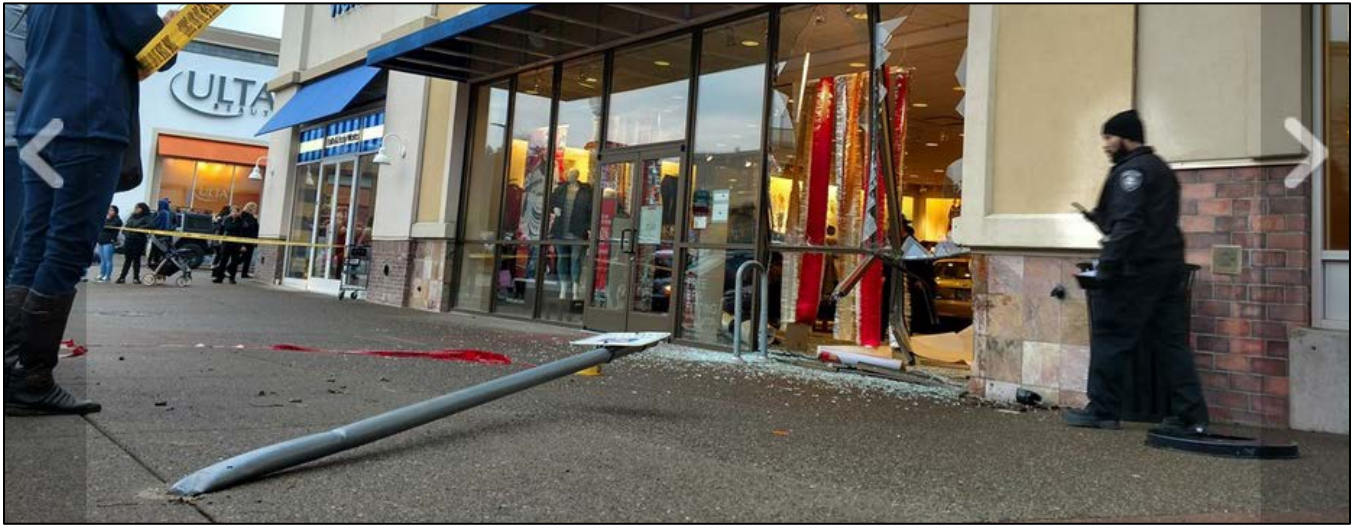
**Photo 1 of 3: in Gresham, Oregon – by supporting this metal ADA signpost with a safety bollard...**

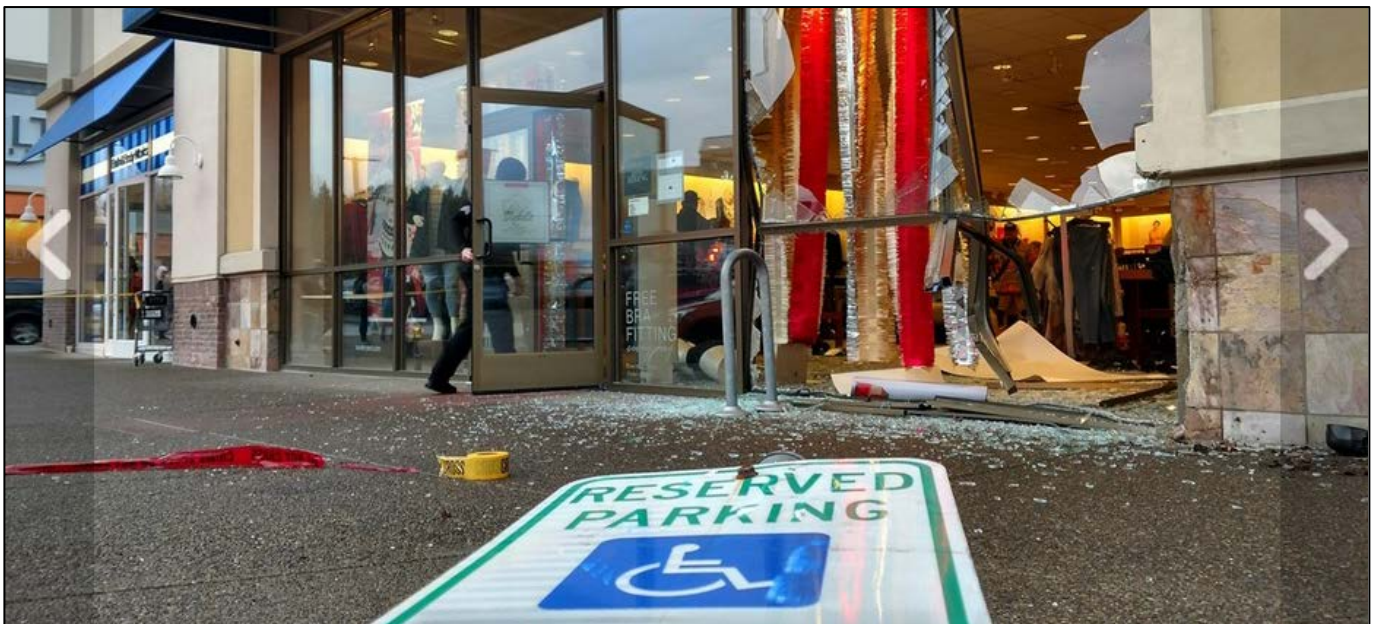
**Photo 2 of 3: ... this vehicle could have been prevented from smashing through the storefront window...**

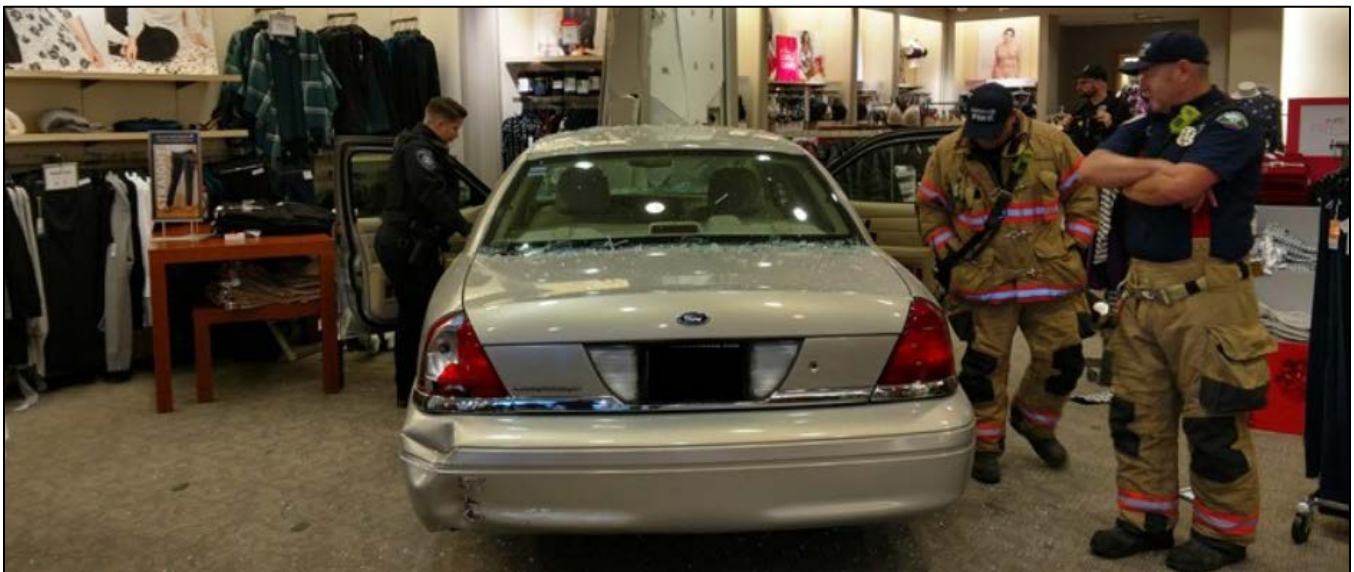
**Photo 3 of 3: ...and deep into this crowded store!**

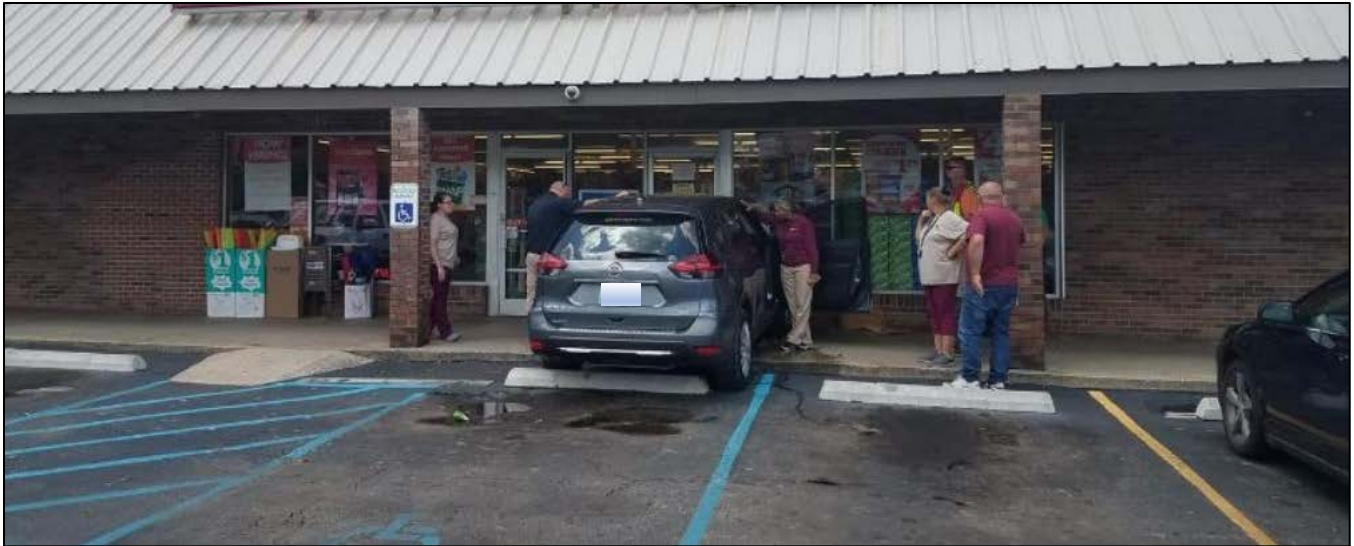
Similarly, a safety bollard could have protected this store in Montgomery, KY...

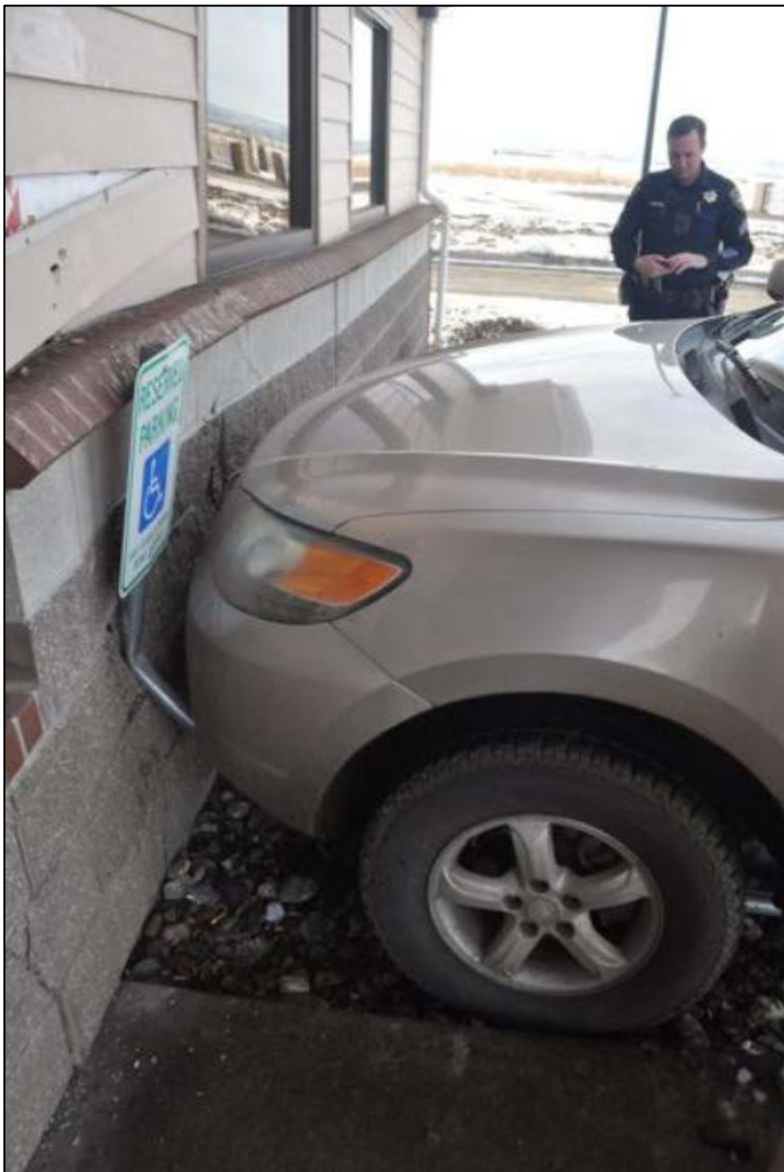
...or this store in Grangeville, Idaho!

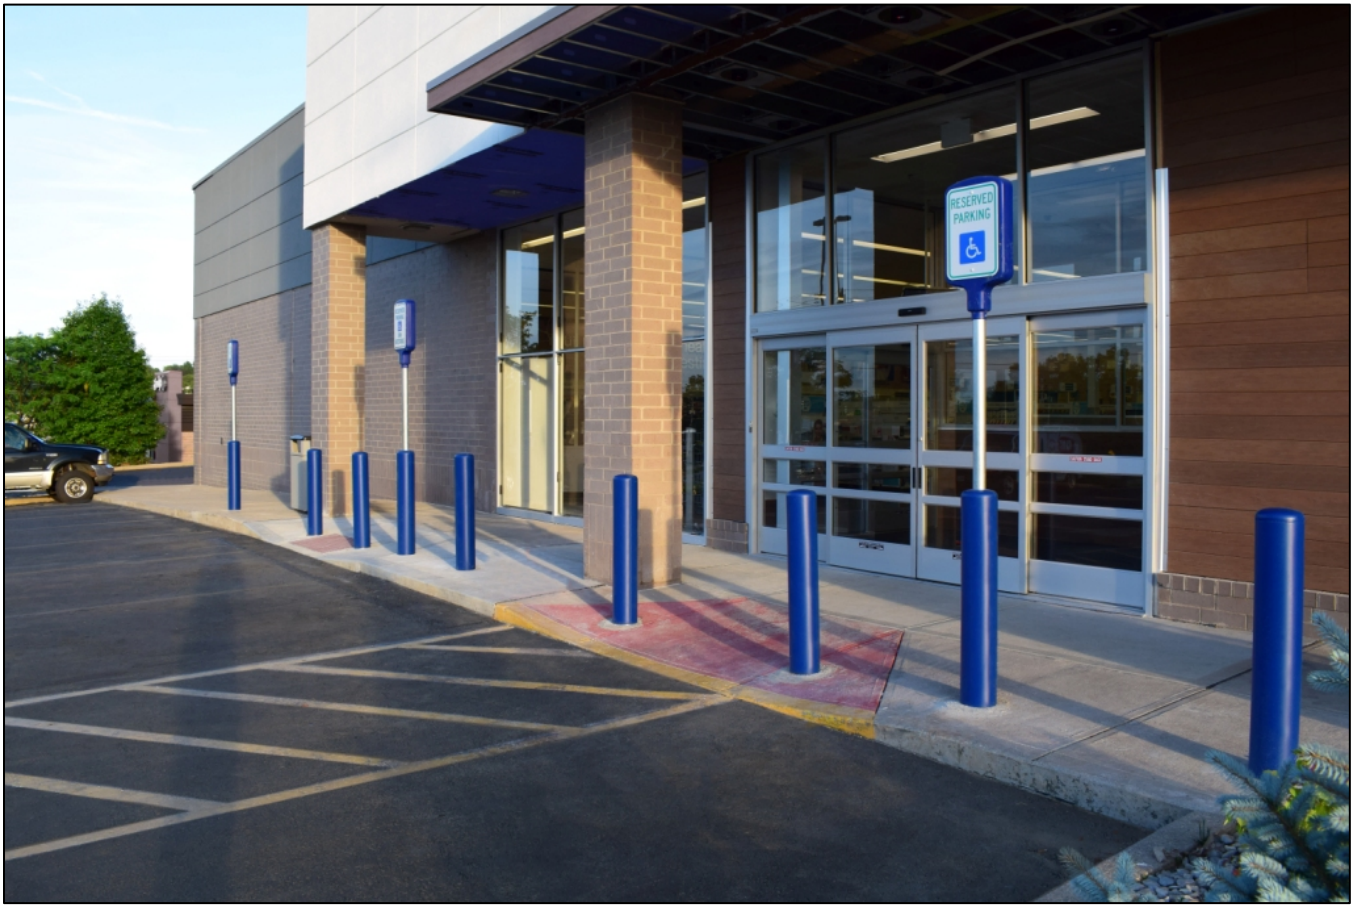
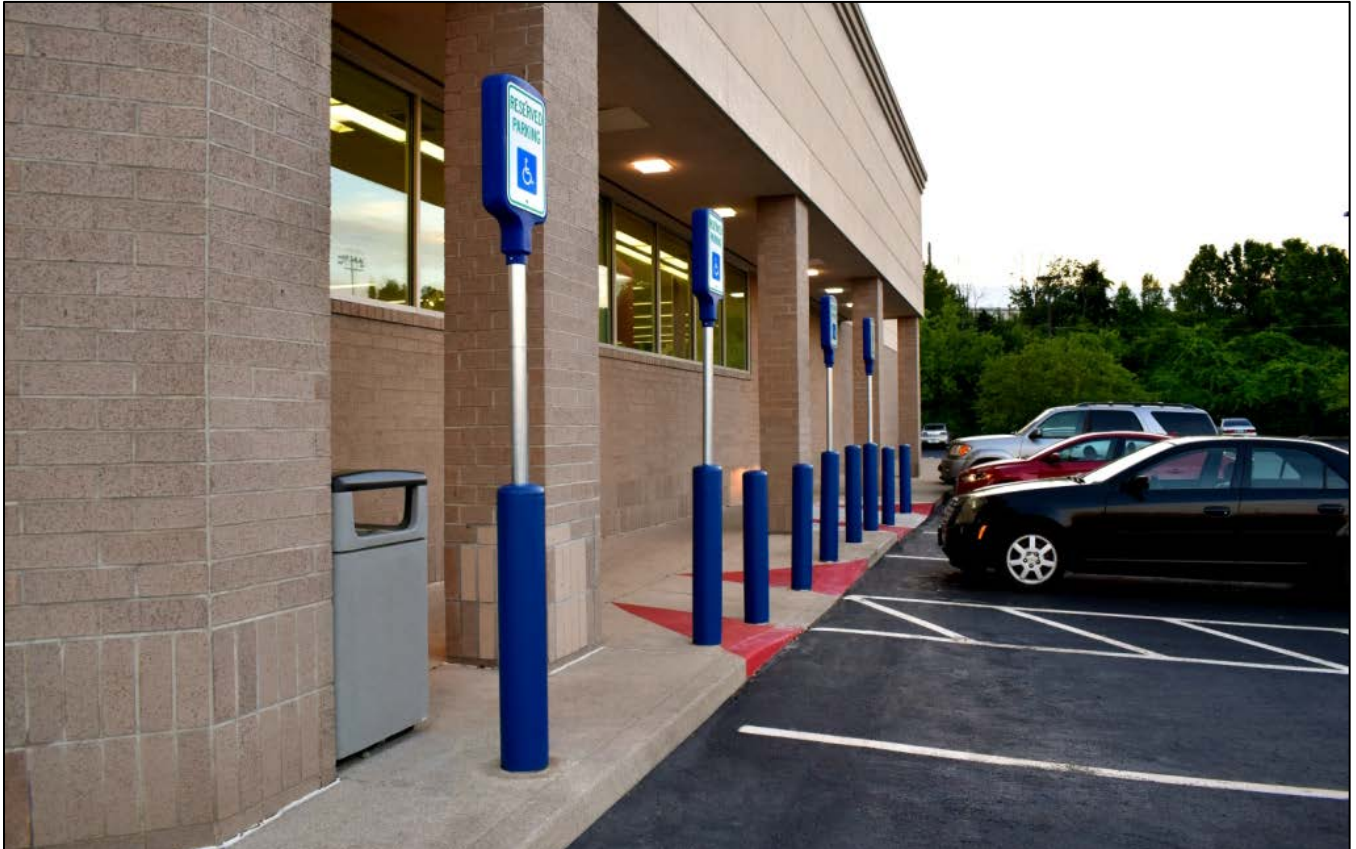
**These ASTM F3016-tested safety bollards in Massachusetts represent modern “best practice” and the future industry standard for life safety protection at accessible parking spaces at busy storefronts.**

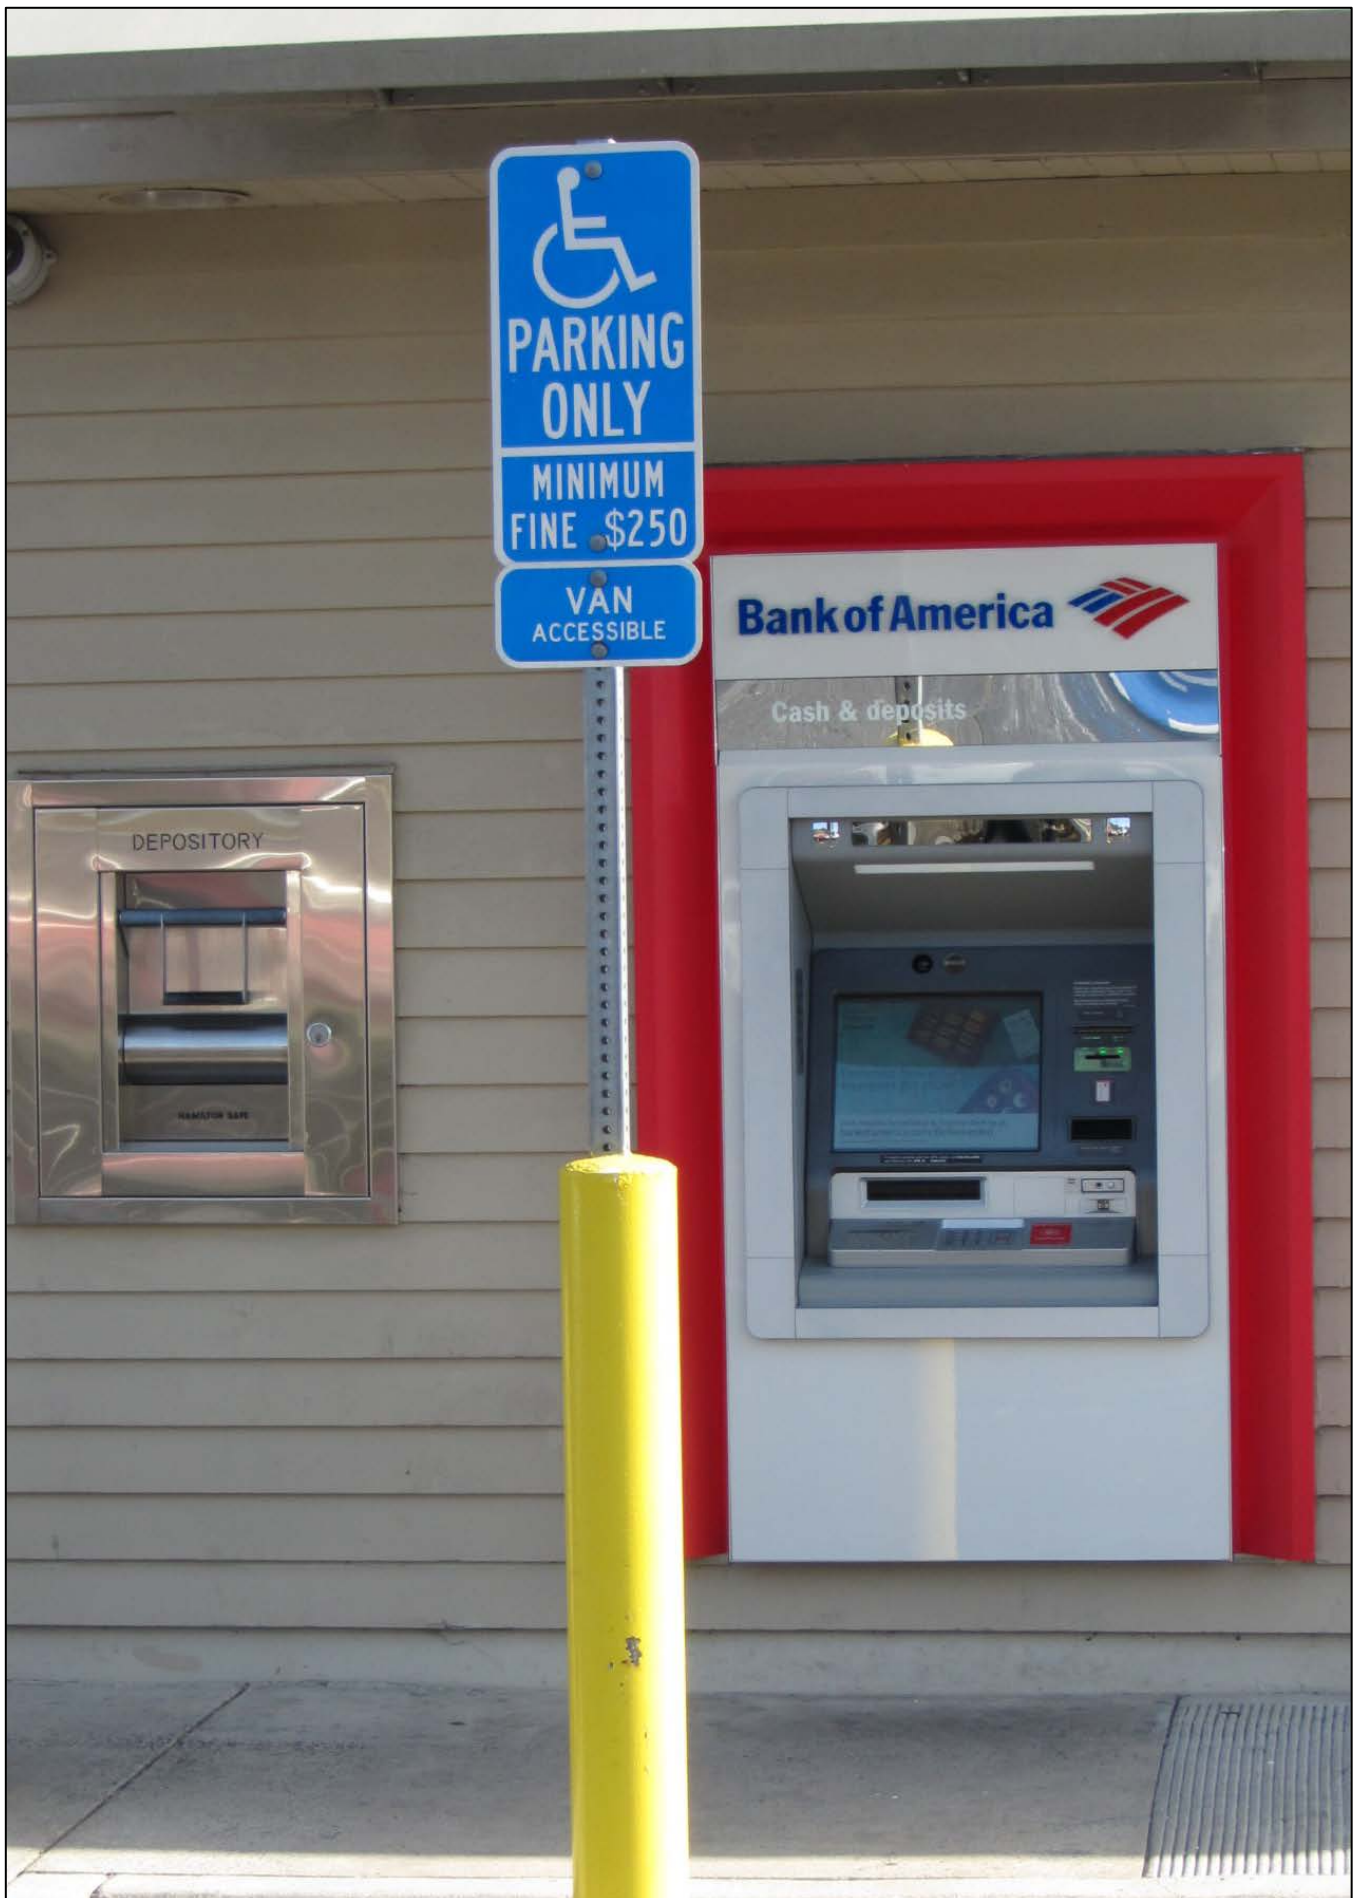
**This safety bollard in Dana Point, CA serves to prevent vehicle crashes while also protecting the bank's customers.**

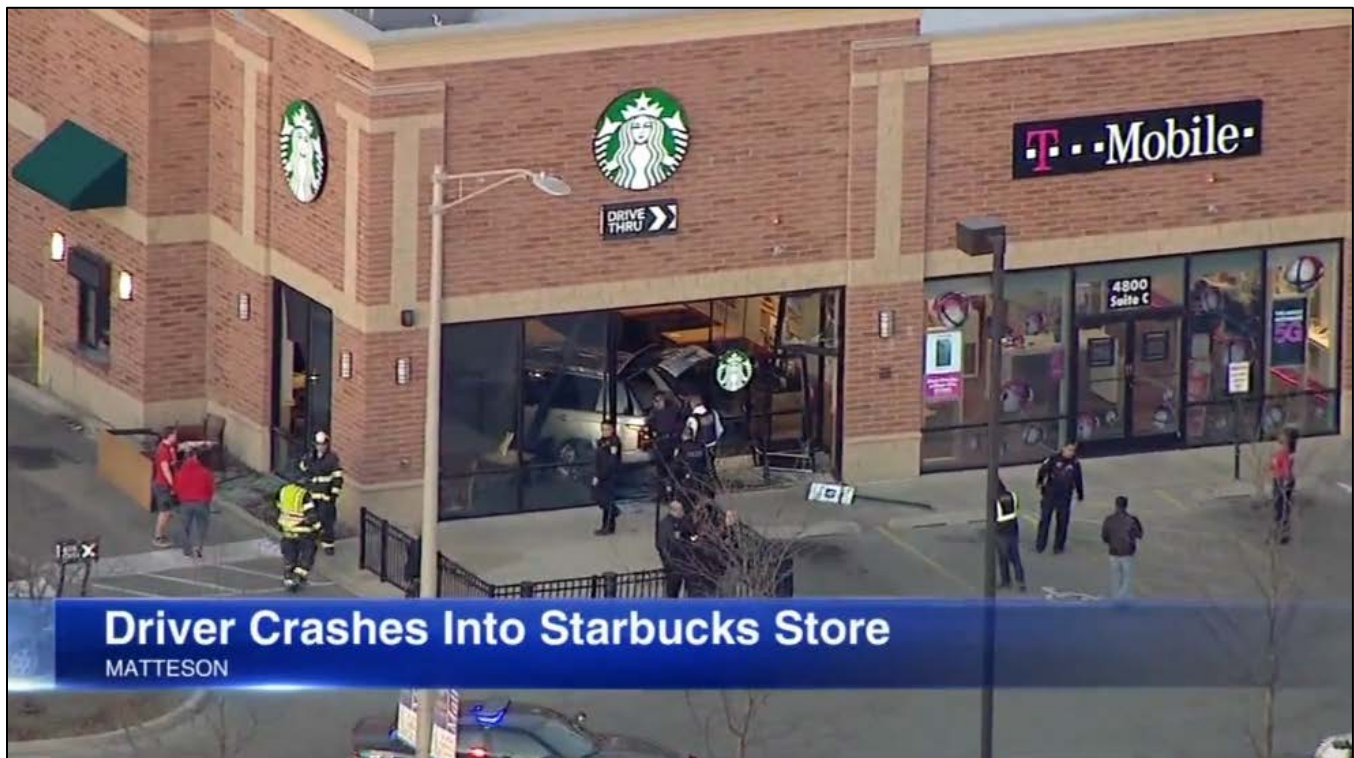
- ✓ *The collapsed ADA signpost and the severely damaged storefront present striking evidence of how well a safety bollard could have protected the driver, the building, and the store's patrons.*

Screenshot from excellent video by Chicago's ABC7 News: (<http://www.storefrontsafety.org/blog/with-one-simple-change-landlords-and-retailers-can-increase-safety-and-reduce-risk-from-trip-fall-incidents-and-storefront-crashes>).

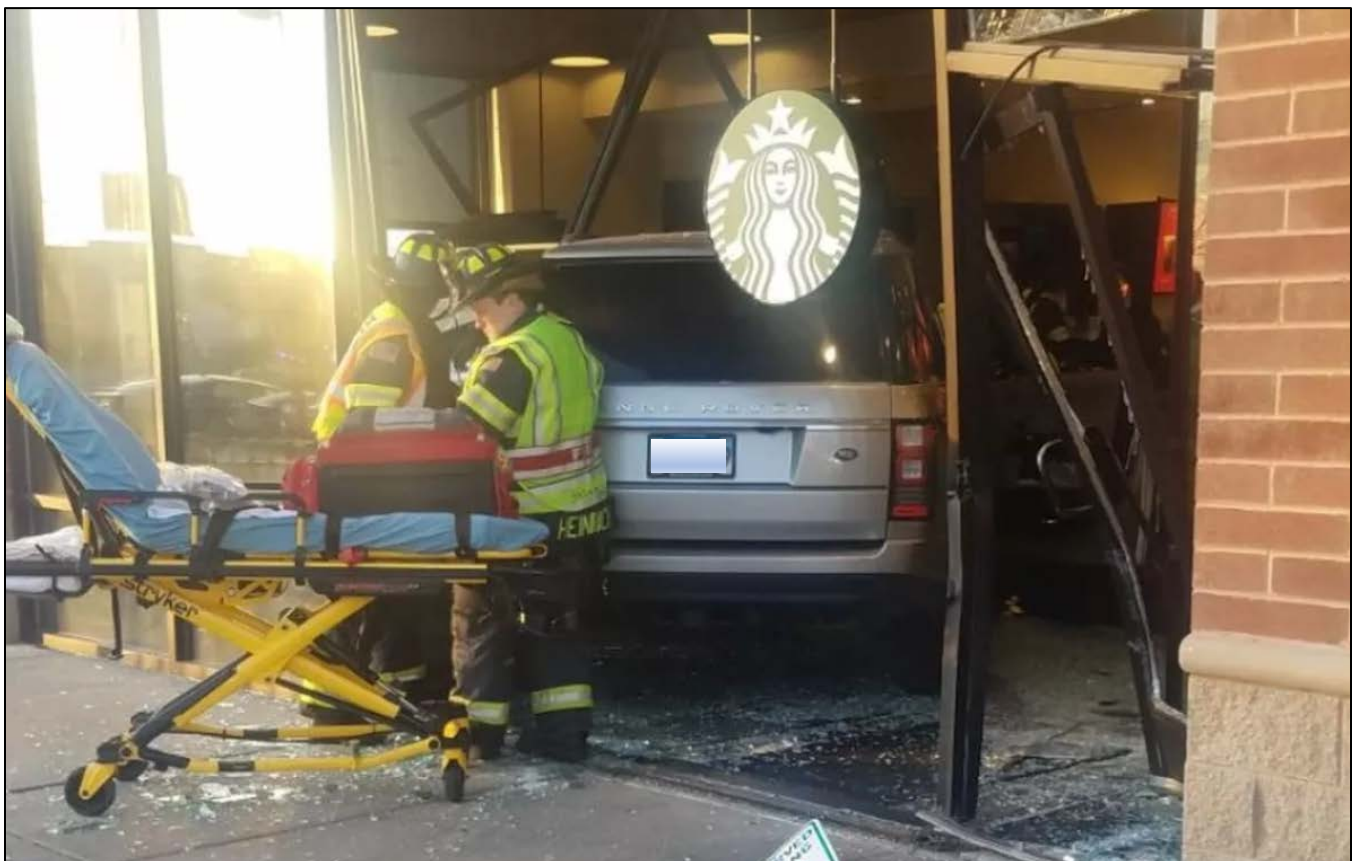
**Such accidents and injuries could be prevented by encasing the required ADA signpost within a safety bollard!**

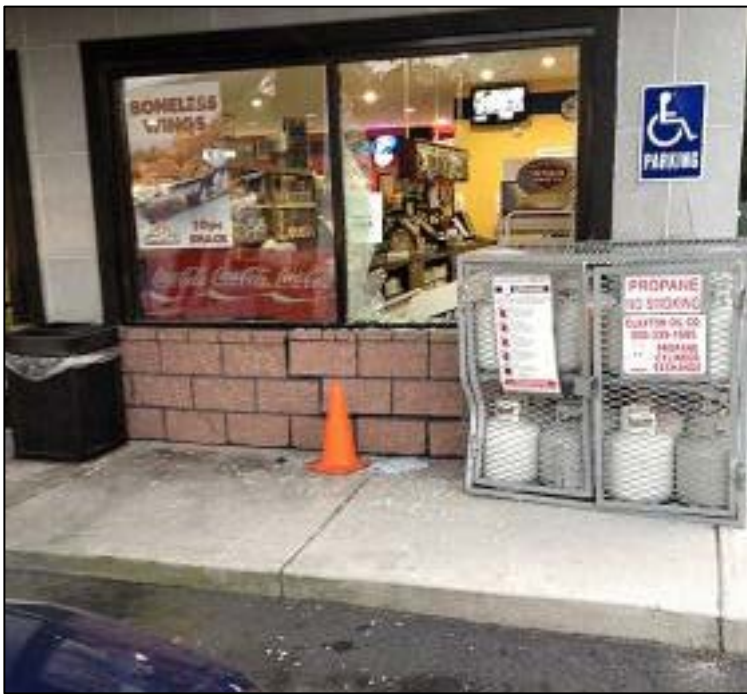
This store owner has positioned propane tanks directly in front of this accessible parking space! (Note the previous vehicle damage to the lightweight-steel cage and at the storefront wall.)
