## Position Paper: Let's Eliminate Parking 'Wheel Stops' at Busy Storefronts (December 1, 2019) ©

## Let's Eliminate Parking 'Wheel Stops' at Busy Storefronts

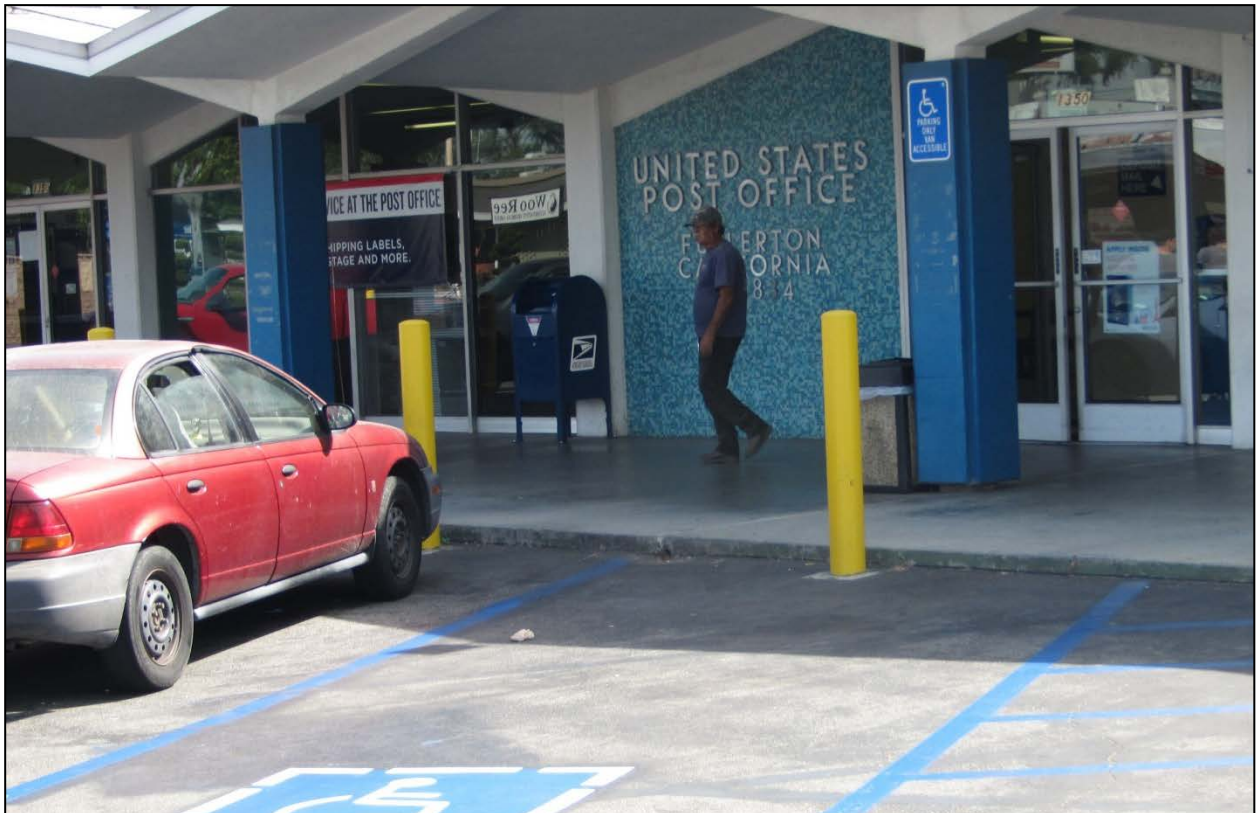
**Photo 2 – Similarly, in this parking lot serving a U.S. Post Office branch in Fullerton, CA, original wheel stops have been replaced with structural bollards to better protect customers and employees.**

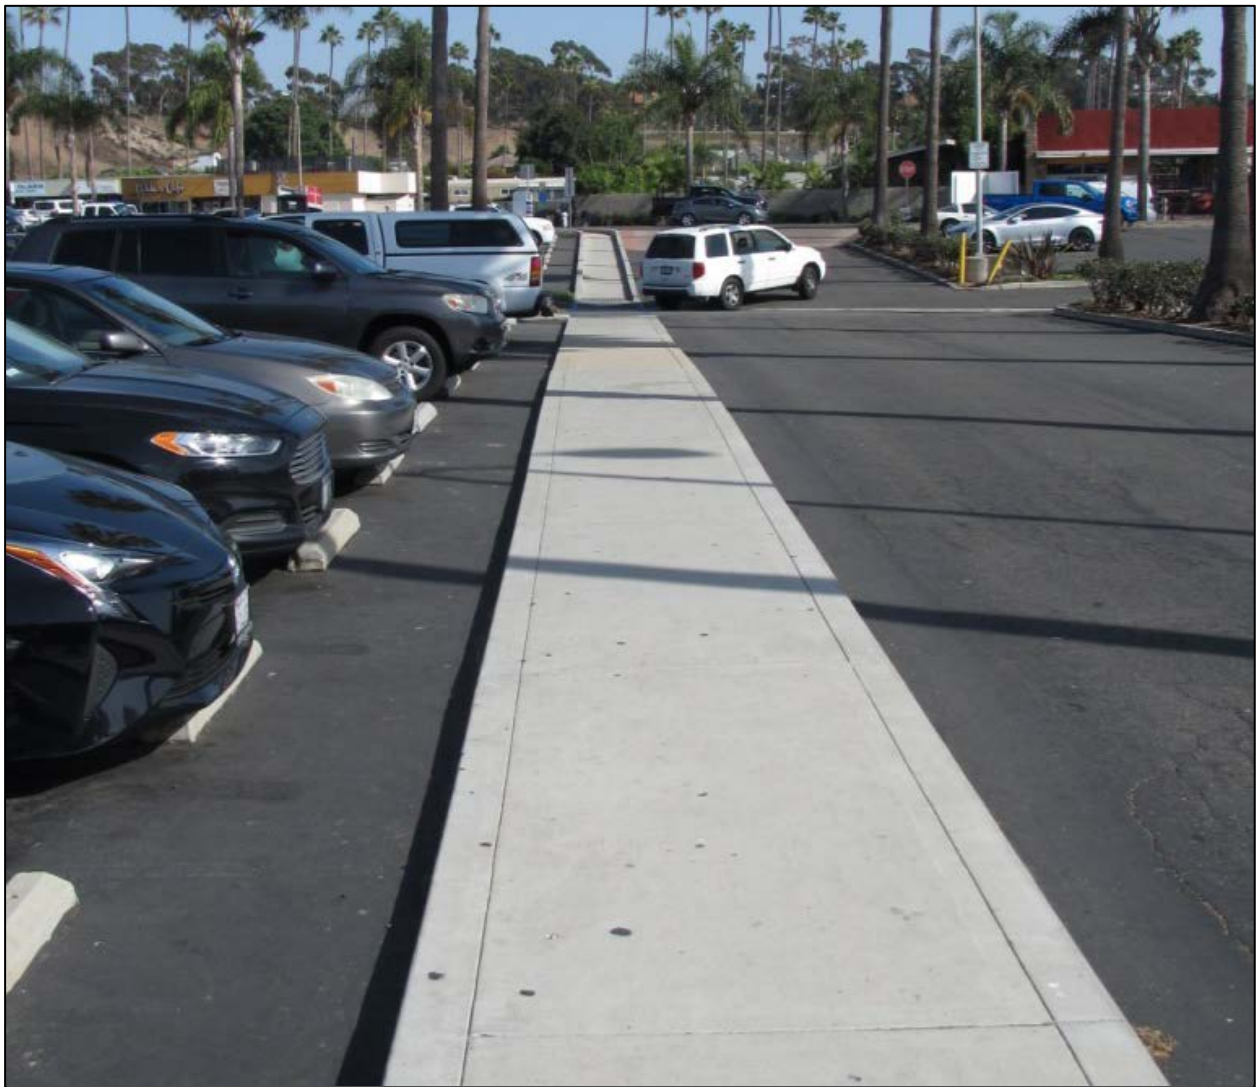
**Photo 3 – At this shopping mall in Southern California, the concrete wheel stops deter vehicle encroachment into the required clear width (60 inches) of this wheelchair-accessible sidewalk.**

As documented and detailed in our prior position paper,<sup>6</sup> installation of wheel stops or similar devices are recommended – by the federal American with Disabilities Act (ADA) and per numerous state codes (e.g., Chapter 11B of the California Building Code) – at accessible parking spaces where necessary to prevent vehicle intrusion into the code-required clear width of adjacent accessible routes, such as sidewalks, as seen at Photo 3 below.

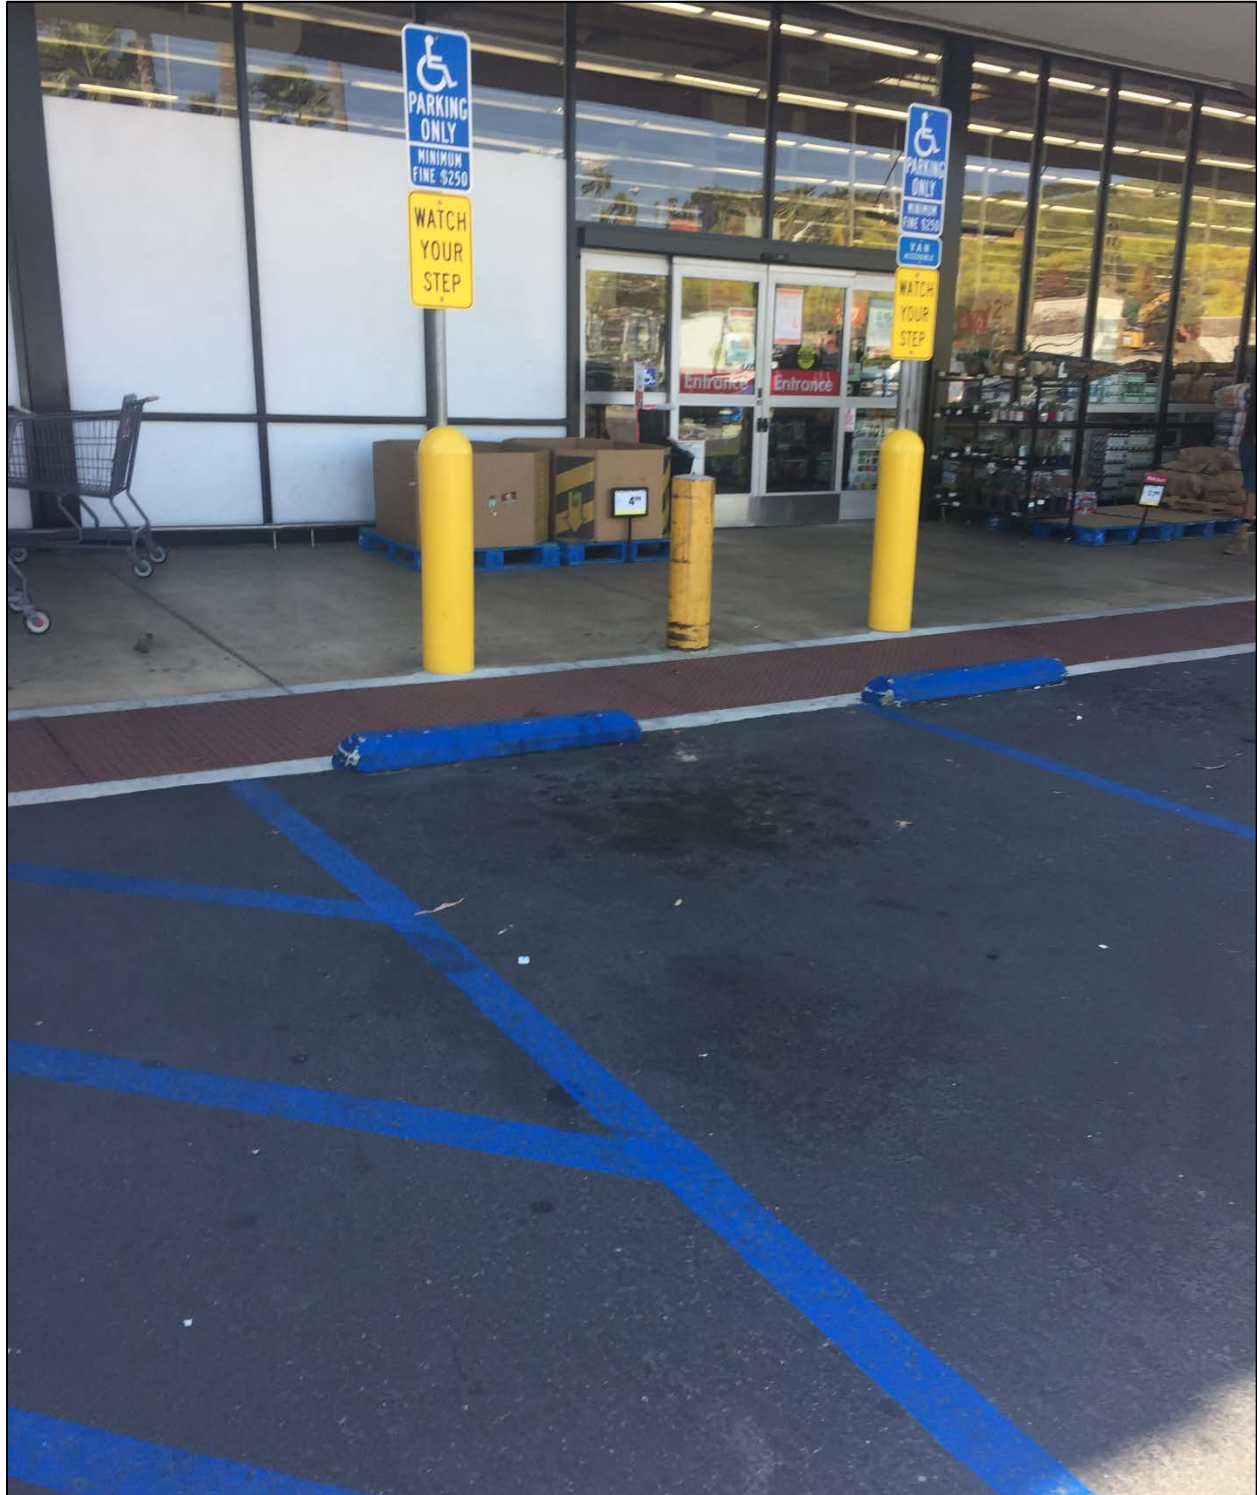
**Photo 4 – At this busy storefront in Southern California, multiple pedestrian customers suffered trip-and-fall injuries at these non-required and unnecessary wheel stops.**

In short, the only code-mandated purpose of a wheel stop is to deter potential vehicle encroachment into the required clear width of an accessible sidewalk or route. Therefore, at Photo 4, because the bollards in front of the accessible parking spaces at this busy storefront preclude any degree of vehicle encroachment into the accessible sidewalk (behind the bollards), there was no code mandate to install these wheel stops at which multiple pedestrian customers later suffered trip-and-fall injuries.

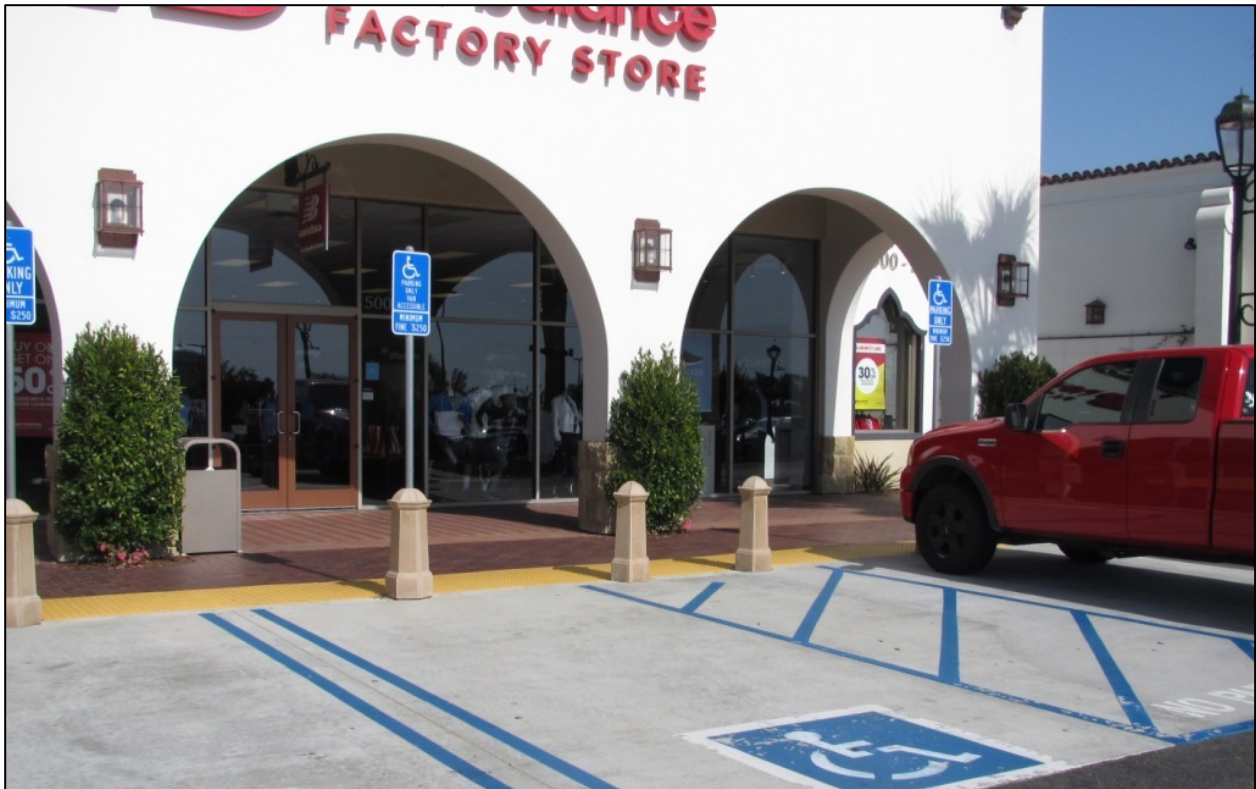
**Photo 5 – Structural bollards prevent vehicular encroachment into the accessible route of pedestrian travel.**

More and more, parking lot designers and managers have recognized the benefits of using structural bollards in lieu of wheel stops. In Photos 5 thru 7 below, there are no wheel stops anywhere at this large shopping mall in Southern California:

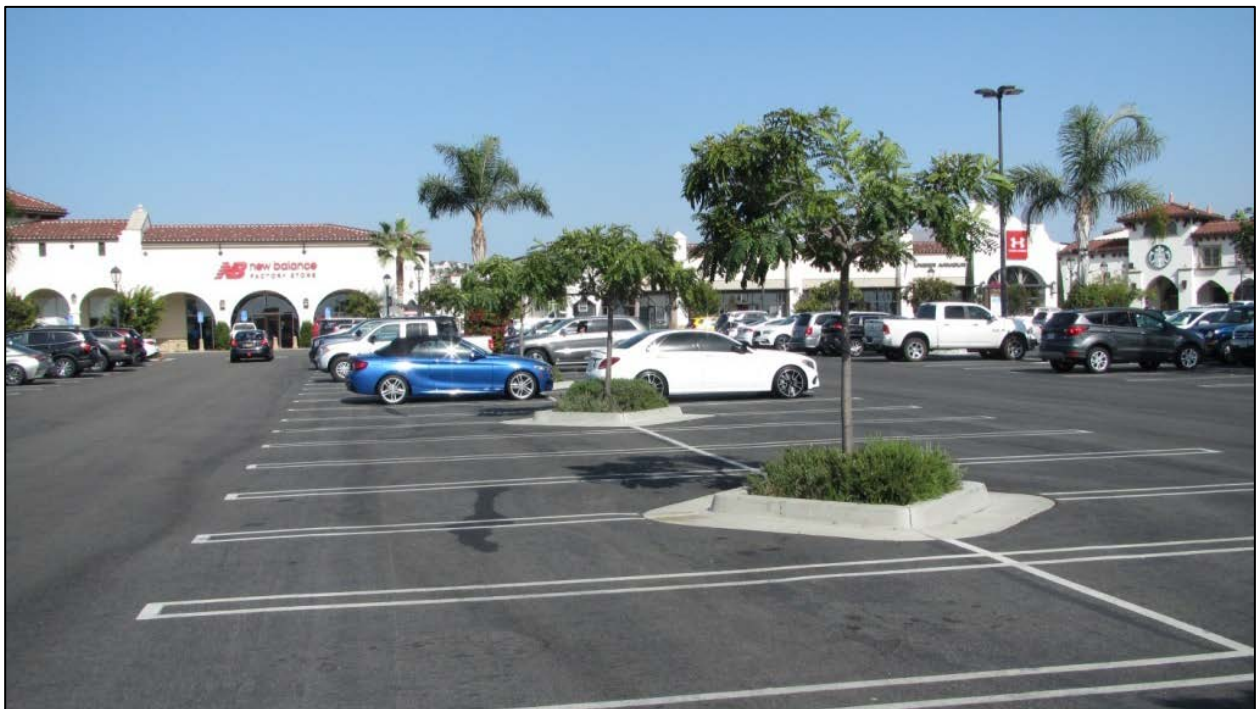
**Photo 6 – The large parking lot in Southern California was designed and constructed without wheel stops, which are potential tripping hazards (and which are not required by state or federal laws, codes, or regulations).**

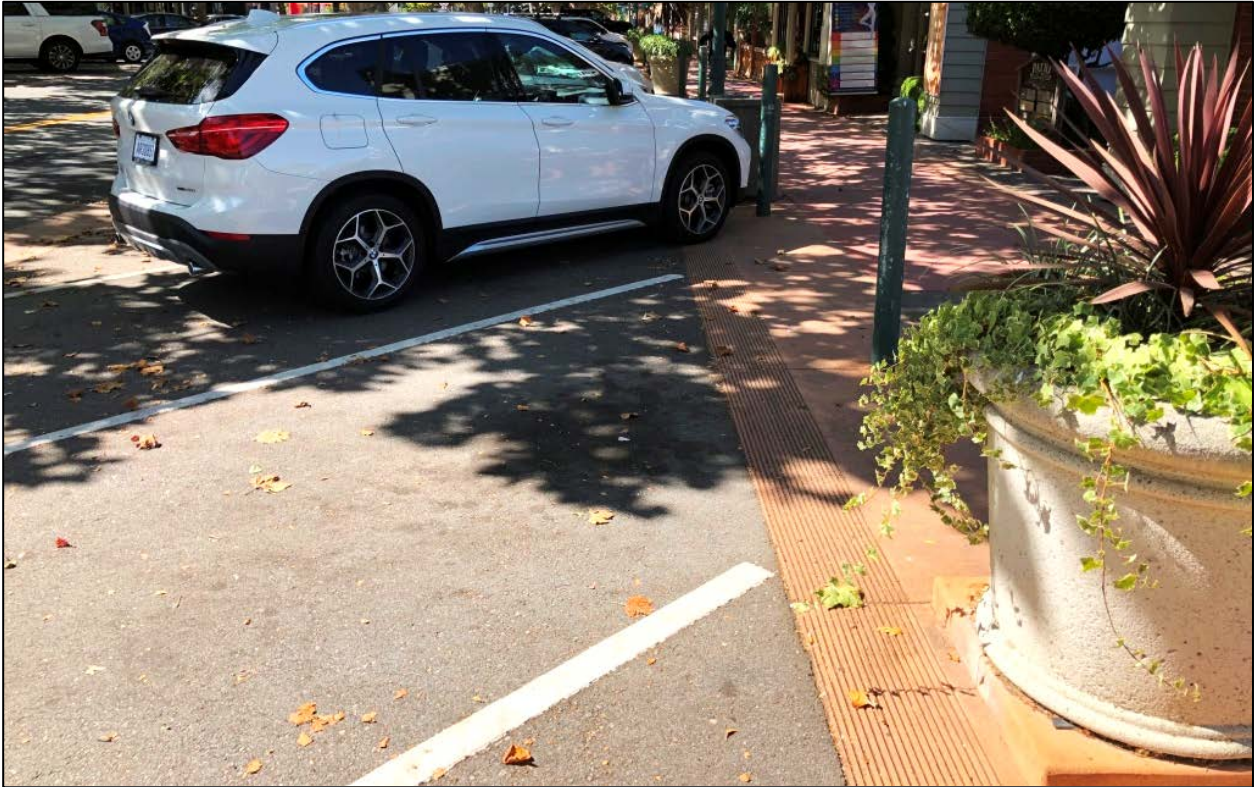
**Photo 8 – City of Novato’s revitalized “Old Town” district: structural bollards, lamp poles, and planters prevent vehicular encroachment into the accessible public sidewalks.**

Similarly, in Photos 8 and 9 below, note how the City of Novato (in Northern California), during the highly successful revitalization of its “Old Town” district, has strategically positioned structural bollards, light poles, and large planters to eliminate the need for wheel stops or curbs to deter vehicular encroachment into the public sidewalks. Also note the modern “zero curb” transition fostered by the strategic use of bollards and other barriers.

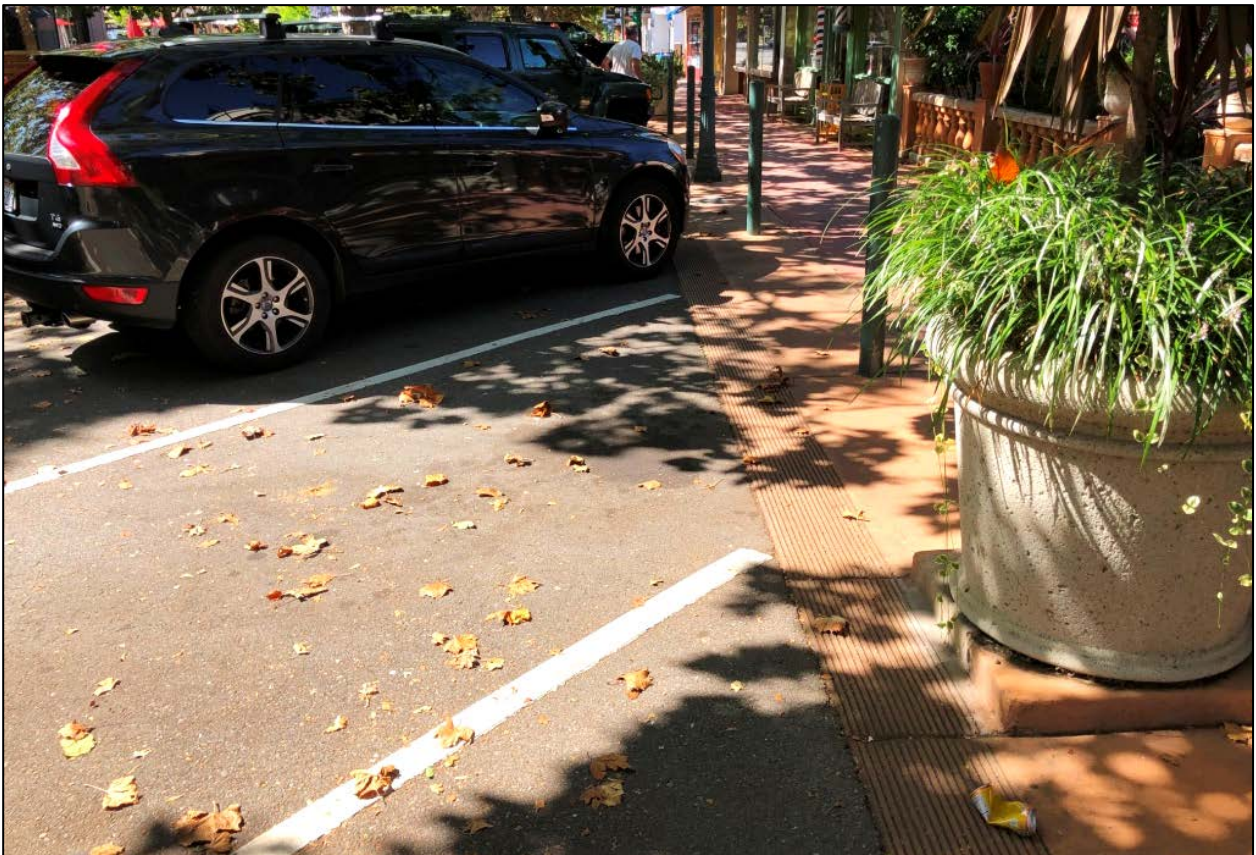
**Photo 9 – City of Novato’s revitalized “Old Town” district: structural bollards, lamp poles, and planters prevent vehicular encroachment into the accessible public sidewalks.**

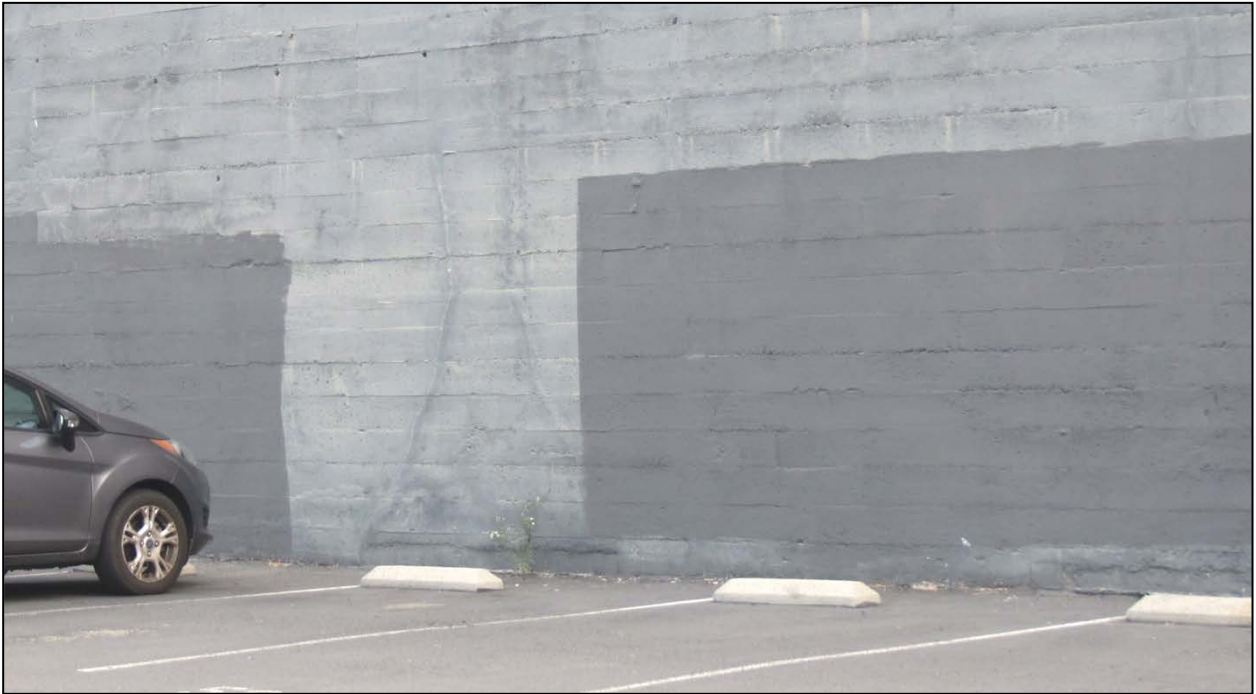
**Photo 10 – These distinctive wheel stops, which are not located within an intended pedestrian route, reasonably (in our opinion) serve to protect drivers and their vehicles from damaging interactions with this concrete wall.**

- “*not utilizing wheel stops in pedestrian path areas (only against walls or boundary conditions where pedestrians cannot travel);*” (E.g., see Photo 10 below.)
- “*...using boundary control and curb placement that avoids vehicle overhang into public right of way and sidewalks...*” (E.g., see Photos 1, 2, 8, and 9 above.)
- “*Where curbless design is used, the sign post can be placed at the head of the accessible parking space (with protection such as bollard) to limit encroachment into the accessible route (wheel stops should not be used).*” (E.g., see Photos 5 and 7 above and 17 below.)

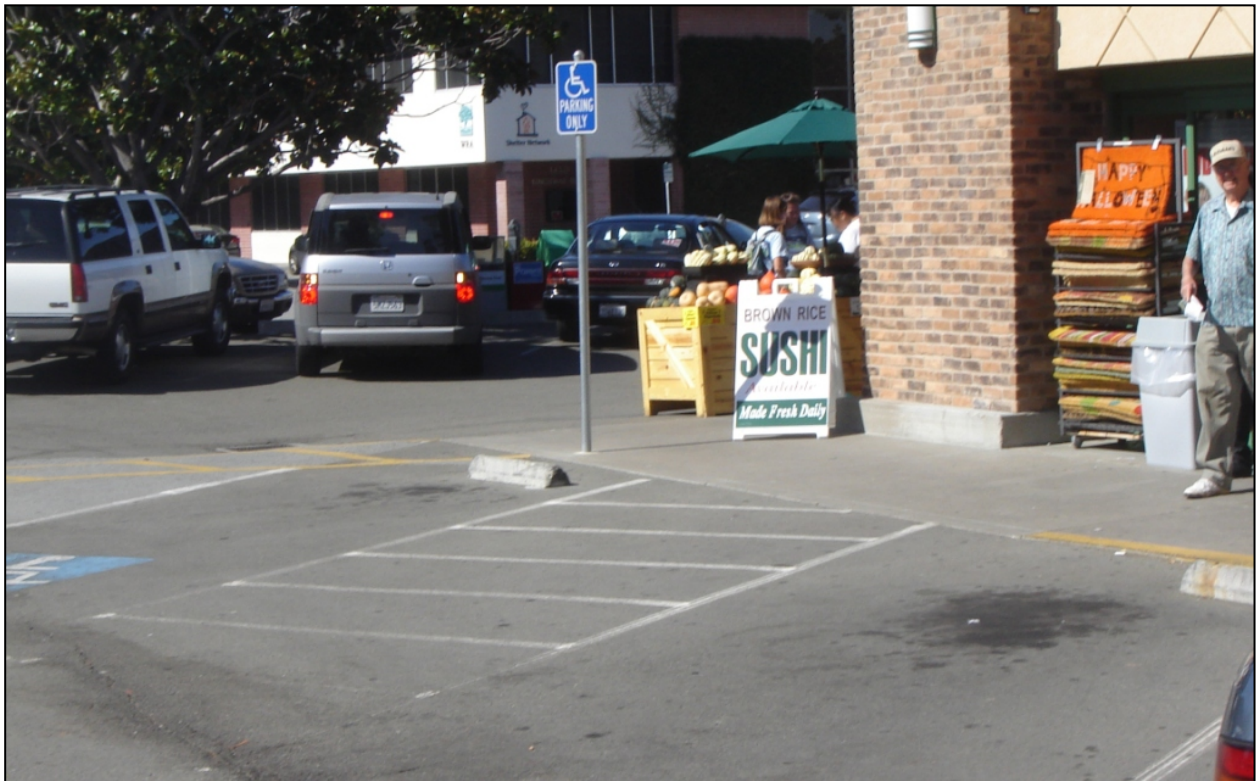
**Photo 11 – These wheel stops did not prevent a driver from accidentally accelerating into a group of young girls selling cookies at the often-crowded entryway to this grocery store.**

Consider, at Photo 11 below, the two parking spaces positioned directly adjacent to the entrance of a popular grocery store in Northern California. For years, this narrow entryway also had been used at various times by local community groups for their fundraising purposes, until an elderly driver who mistook his car's gas pedal for the brake pedal inadvertently drove over a wheel stop into a group of young girls selling cookies.

A key dispute of the ensuing litigation was whether or not the store owner had reasonably assessed and abated potential risks of accidents related to this vehicle/pedestrian interaction zone. In particular, should the owner have recognized that bollards were needed to prevent foreseeable vehicle intrusion into this often-crowded entryway?

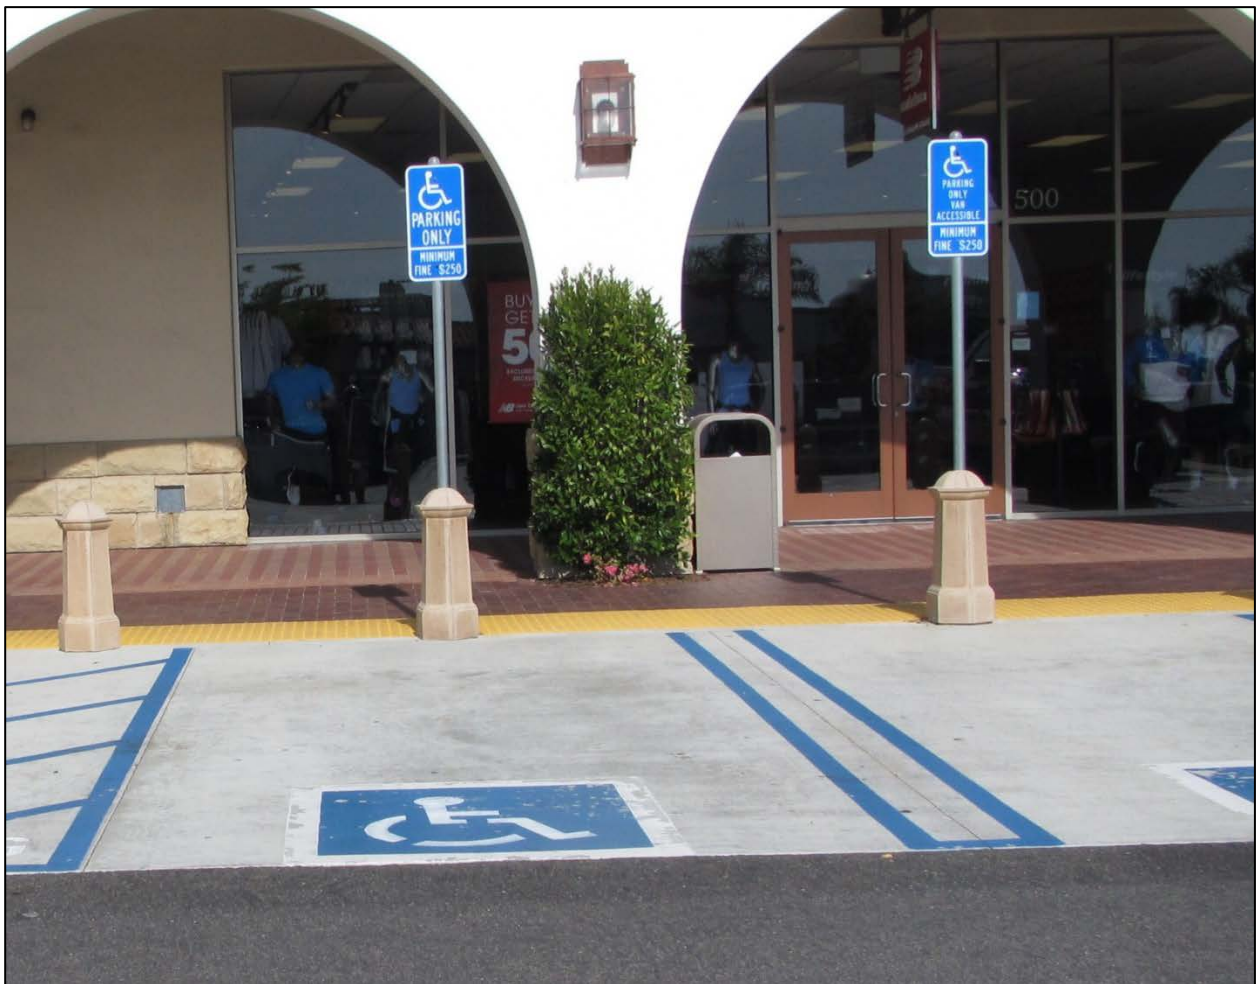
**Photo 12 – Structural bollards also protect the required signposts at these accessible parking spaces.**

Further, an additional degree of safety at accessible parking spaces is provided when posts supporting required signage are encased and protected (i.e., compare Photo 12 below with Photo 11 above) by bollards. Otherwise, when a vehicle accidentally hits a signpost, it is not uncommon for the metal sign to fold forward into the car window – potentially injuring the occupants.

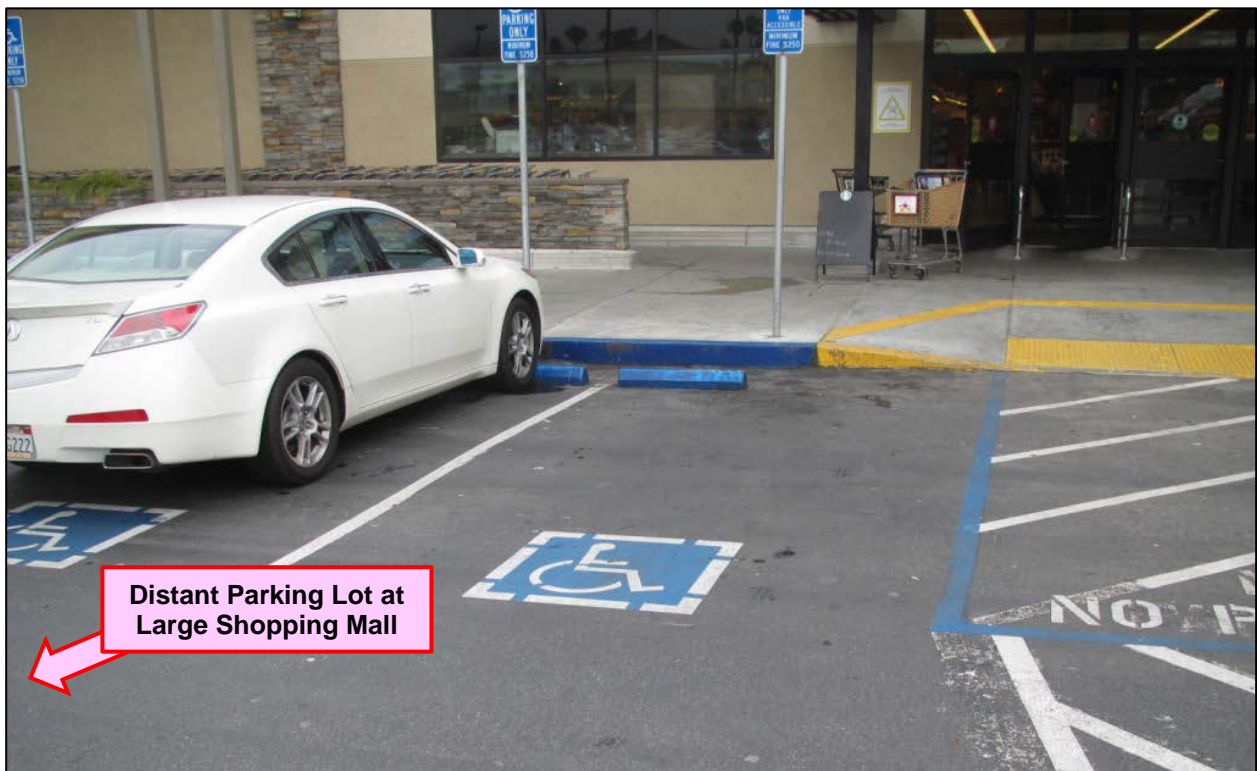
**Photo 13 – At this busy storefront, patrons steadily stream across the wheel stops at these accessible parking spaces while traveling to and from a distant parking lot at a large shopping mall in Northern California.**

In short, while there is no code or standard that requires the creation of new accessible parking spaces directly in front of busy storefront entryways, the closest existing parking (wherever located) must be made accessible. Often, as seen in Photos 1, 2, 4, 5, 11, and 12, it does make the most sense (socially and economically) to provide these accessible spaces directly at busy storefronts, per Photo 13:

However, in our professional opinion, this store's customers would be better served (and far safer) if owners or managers elected to: a) install structural bollards, preferably compliant with ASTM F3016, and b) eliminate these existing wheel stops, which serve no code-required nor code-recommended purpose (and at which one or more injurious falls are known to already have occurred).

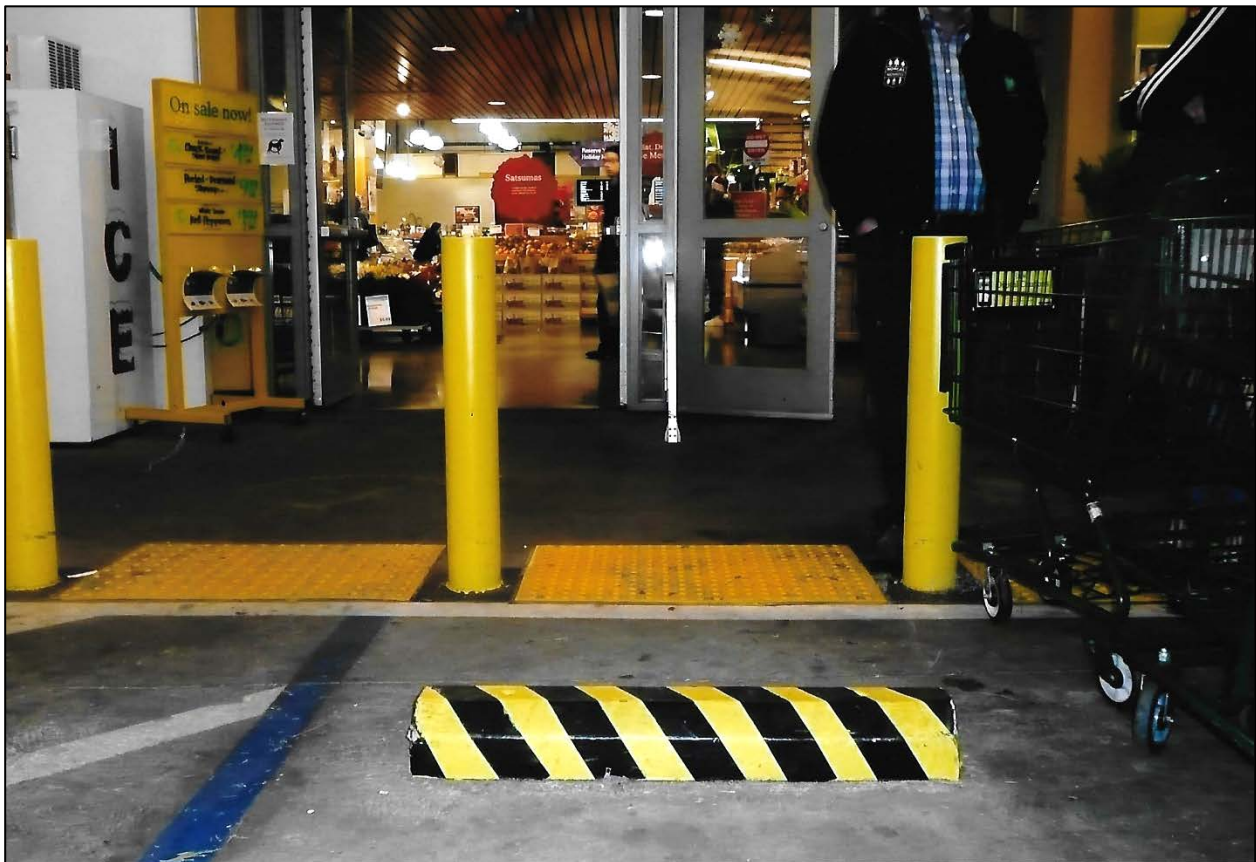
**Photo 14 – Case Study #1: after multiple pedestrian falls, this dangerous, non-required wheel stop was removed.**

Consider, at Photo 14, the dangerously positioned wheel stop at an accessible parking space serving a popular grocery store in Northern California. After multiple pedestrian injuries, store managers had the wheel stops painted with black/yellow striping --- unfortunately, such falls continued to occur.

- Eventually, upon litigation by an injured customer, the managers (presumably after consultation with an appropriate professional) acknowledged that the presence of the structural bollards fully obviated any code-required need for these wheel stops and had them removed (Photos 15 and 16).

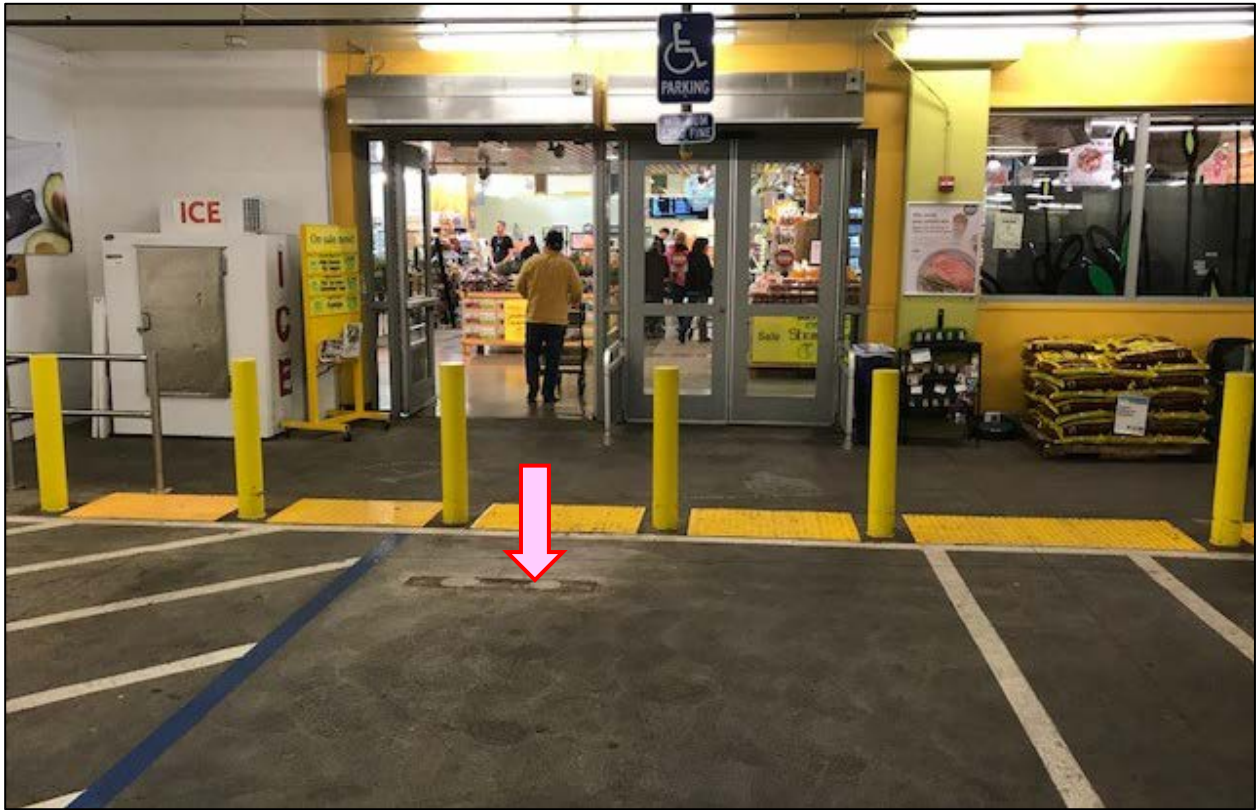
**Photo 15 – Case Study #1: after multiple pedestrian falls, this dangerous, non-required wheel stop was removed.**

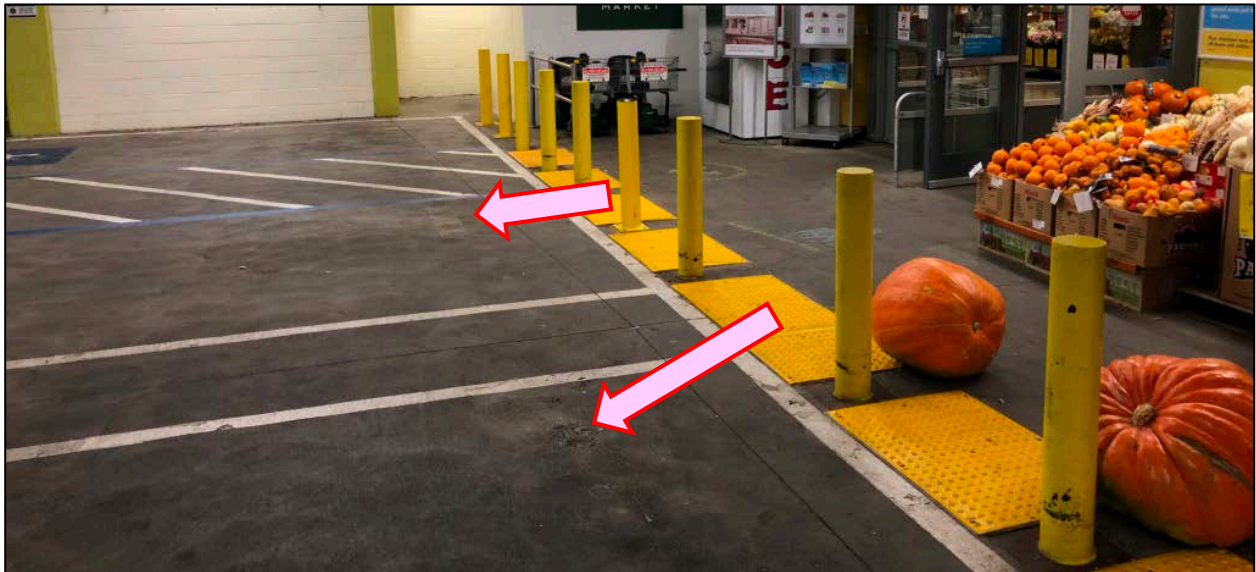
**Photo 16 – Case Study #1: after multiple falls, these dangerous, non-required wheel stops were removed.**

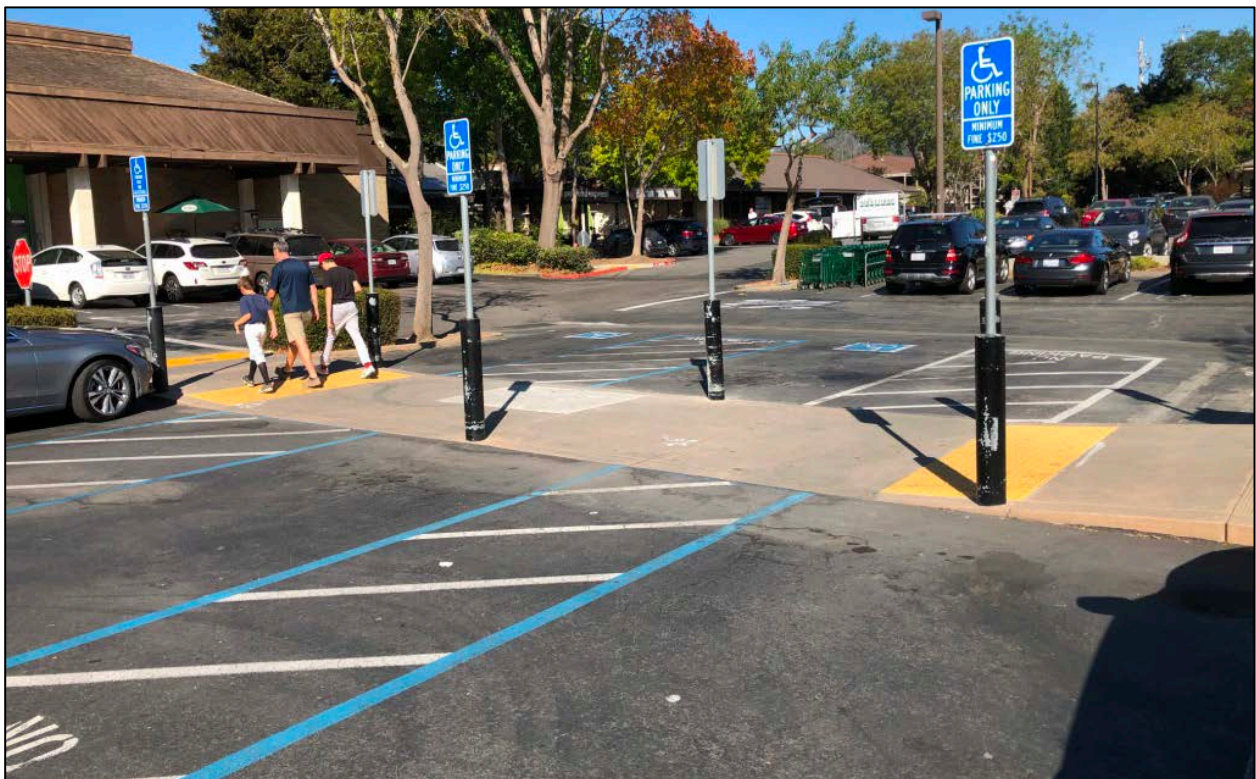
Photo 17 – Case Study #2: These well-designed accessible parking spaces serve the wheelchair-accessible walkway leading to the main entry (at left) at a highly popular store in Northern California.

Consider at Photo 17, at a popular grocery store in Northern California, the well-designed accessible parking spaces serving the wheelchair-accessible path of travel to the main entry. Structural bollards prevent vehicle encroachment into this wheelchair-accessible path of travel and protect against vehicle-to-pedestrian and vehicle-to-vehicle interactions and also protect required signposts and signage. There are no wheel stops anywhere in this parking lot.

Clearly, upon comparison with the relatively hazardous accessible parking conditions documented in Photos 4, 11, 13, and 14 above, the design professionals responsible for the layout seen in Photo 17 should be commended. Reviewers should note the following:

- Due to existing site conditions, it is not practical to provide wheelchair-accessible parking spaces directly along the storefront (at the left). The parking spaces seen in Photo 17 and the associated pedestrian route are fully ADA-compliant.

- Further, encasing the required signposts into the bollards greatly lessens risks of injury to drivers and passengers caused by smashed windows due to crumpled signage during such accidents.

- Also note: the whitish markings seen on these recently installed black-painted structural bollards simply represent widespread paint failures (due to improper priming of the galvanized steel) – not evidence of vehicle impact.
